## HOME BOSS INSPECTION

### HOME BOSS PROPERTY REPORT COPY

21573 Co Rd 68 N  
Robertsdale, AL 36567

06/21/2025

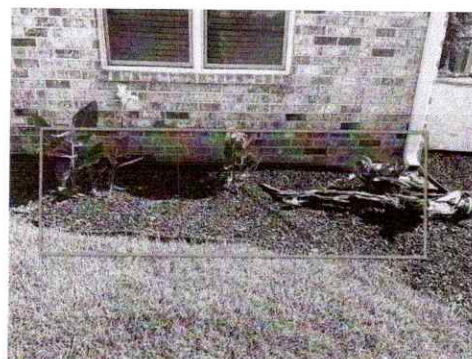
- Flower bed was observed at or near the foundation perimeter. Flower beds can cause a damming effect and hold water next to the structure which in turn can lead to potential foundation issues. Positive drainage should always be maintained even in flower bed locations. It is recommended to monitor and address if issues are identified.

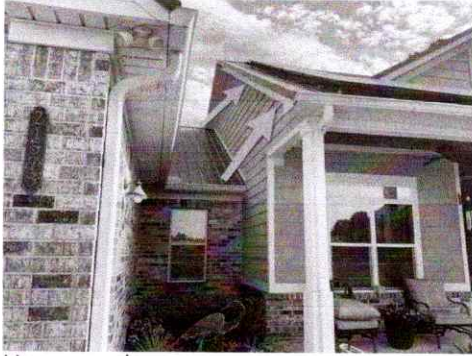
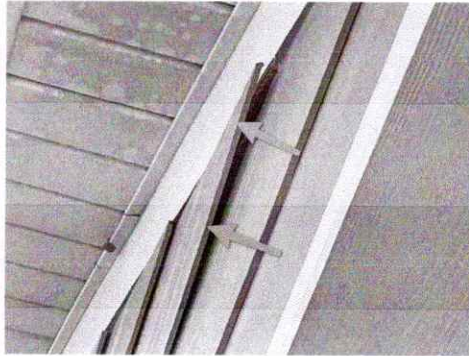
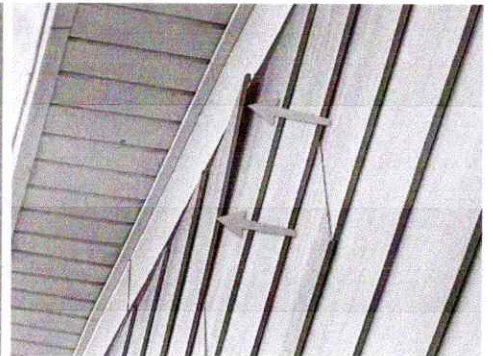
- **Hardie Board/Fiber cement siding, was damaged/cracked, buckled, and/or wavy in referenced location(s). This could be due to improper installation of the hardie board. Recommend further evaluation and repair as needed by a licensed contractor.**

Unsecured

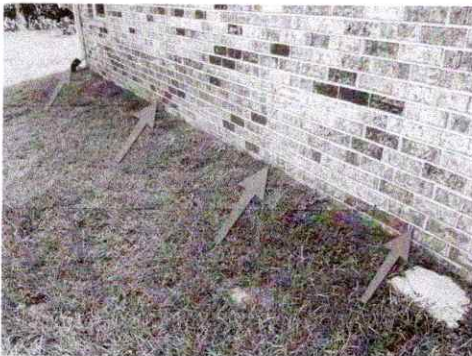
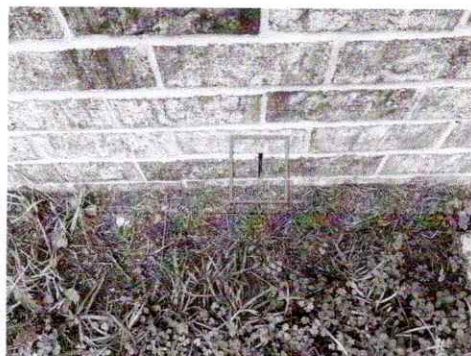
**The brick veneer siding has been installed in close proximity to the finished grade, and the foundation wall is not visible. Additionally, weep holes were noted to be near or at grade level, which may limit proper drainage and increase the potential for moisture intrusion or pest entry. While this condition may reflect the original construction practices from approximately 10 years ago, it is noted here for informational purposes and ongoing monitoring is recommended.**

Weep holes close to grade

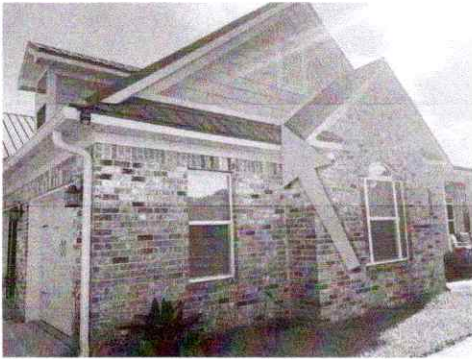
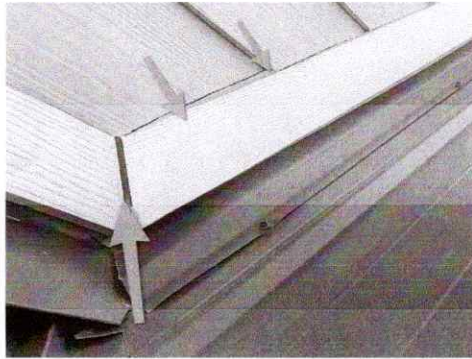
- One or more of the following defects were located on exterior trim : wood rot/damage, unsecured, missing and improper installation. This can allow water & pest intrusion, and damage to the underlying structure. Recommend repairing as needed by a licensed contractor.

Separation/unsecured- Front of home

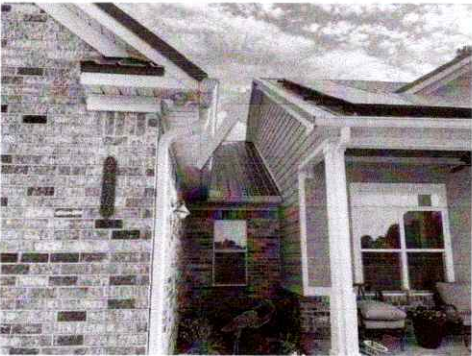
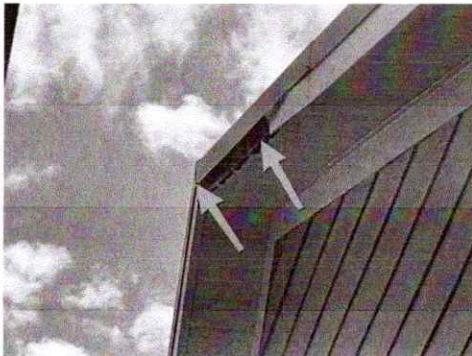
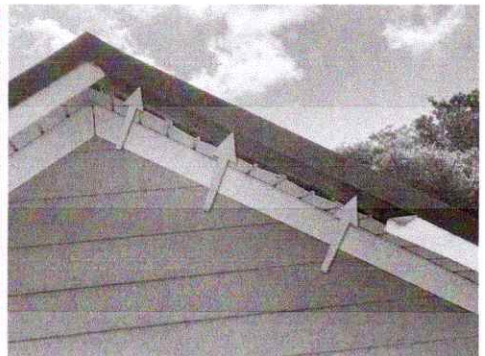
- One or more of the following defects were located on fascia board/covering: wood rot/damage, unsecured, missing, holes/compromised and improper installation. This can allow water & pest intrusion, and damage to the underlying structure. Recommend repairing as needed by a licensed contractor.

Fascia board covering missing

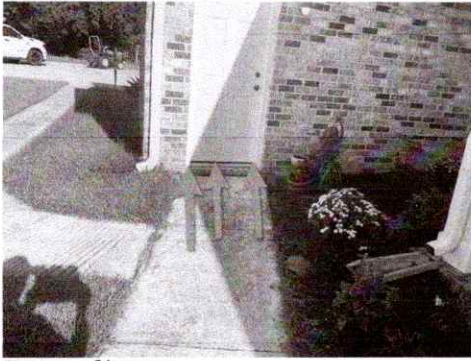
Front of home

- Exterior siding and penetrations, such as doors/windows in referenced areas has missing or deteriorated caulk. Adding or replacing a fresh bead of exterior rated sealant will prevent pest/water intrusion and increase the thermal efficiency of the home. Recommend repair.

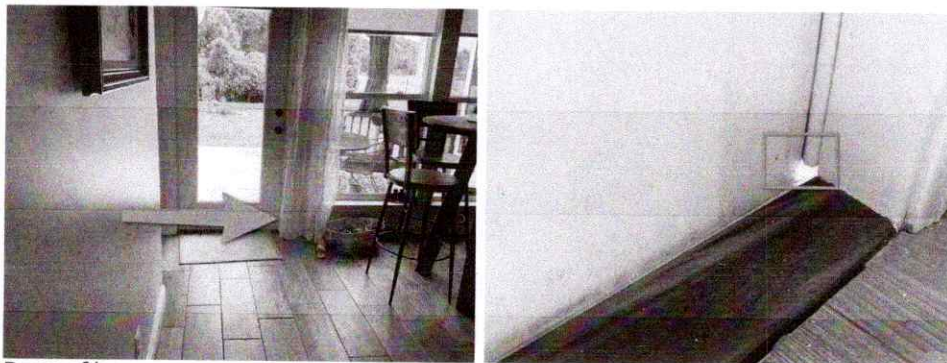
Rear of home

- At the time of the inspection, weather-stripping at doors was generally damaged, missing, or deteriorated. This can allow drafts and reduce the thermal efficiency of the home. Recommend replacement/installation of effective weather-stripping.

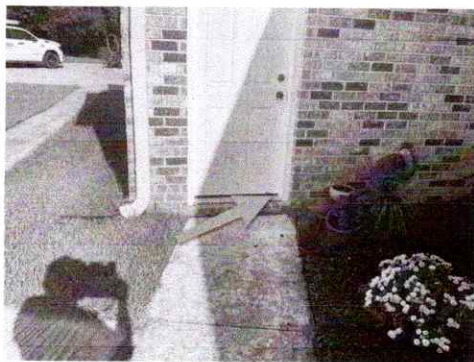
- Door(s) and/or frame has damage or deterioration. This can decrease the energy efficiency of the home and allow water and pest intrusion. Recommend repair.

Some wood rot here

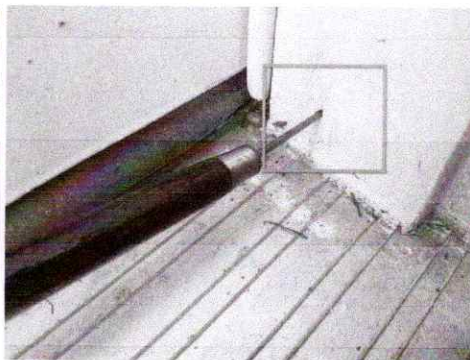
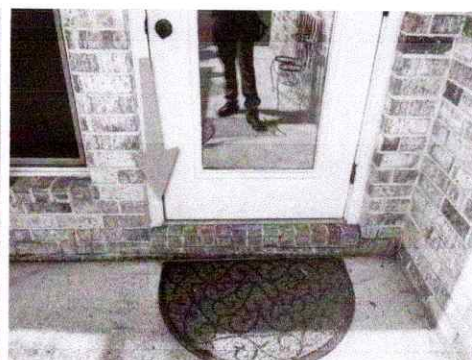
Rear of home

Soft to the touch

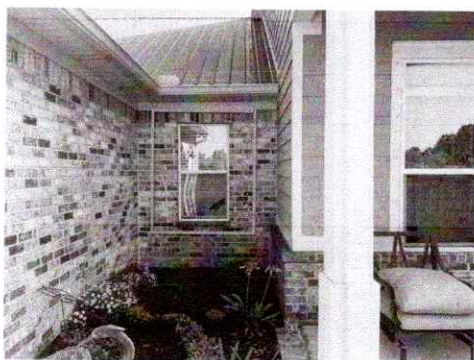
Front of home

- Storm protection hardware, installed around perimeter of exterior openings , are not equipped with their covers in one or more areas, exposing them to the elements, which can promote rust- recommend repair.

Covers being referenced

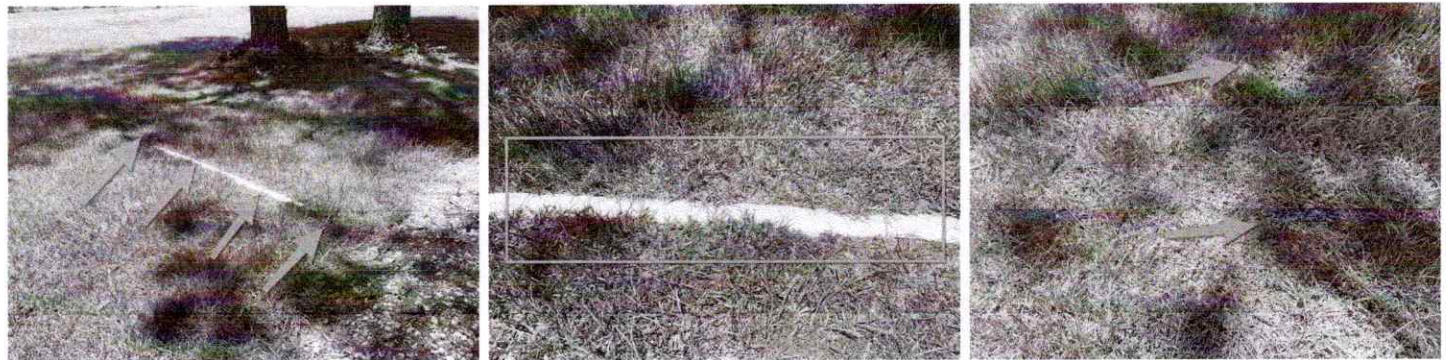
An exposed pipe was observed on the front side of the detached structure. The purpose of this pipe could not be determined during the inspection, but its exposure leaves it vulnerable to physical damage from weather, landscaping, or impact. We recommend evaluation and repair as needed to protect the pipe and ensure it is properly secured and functioning as intended.

Tree roots

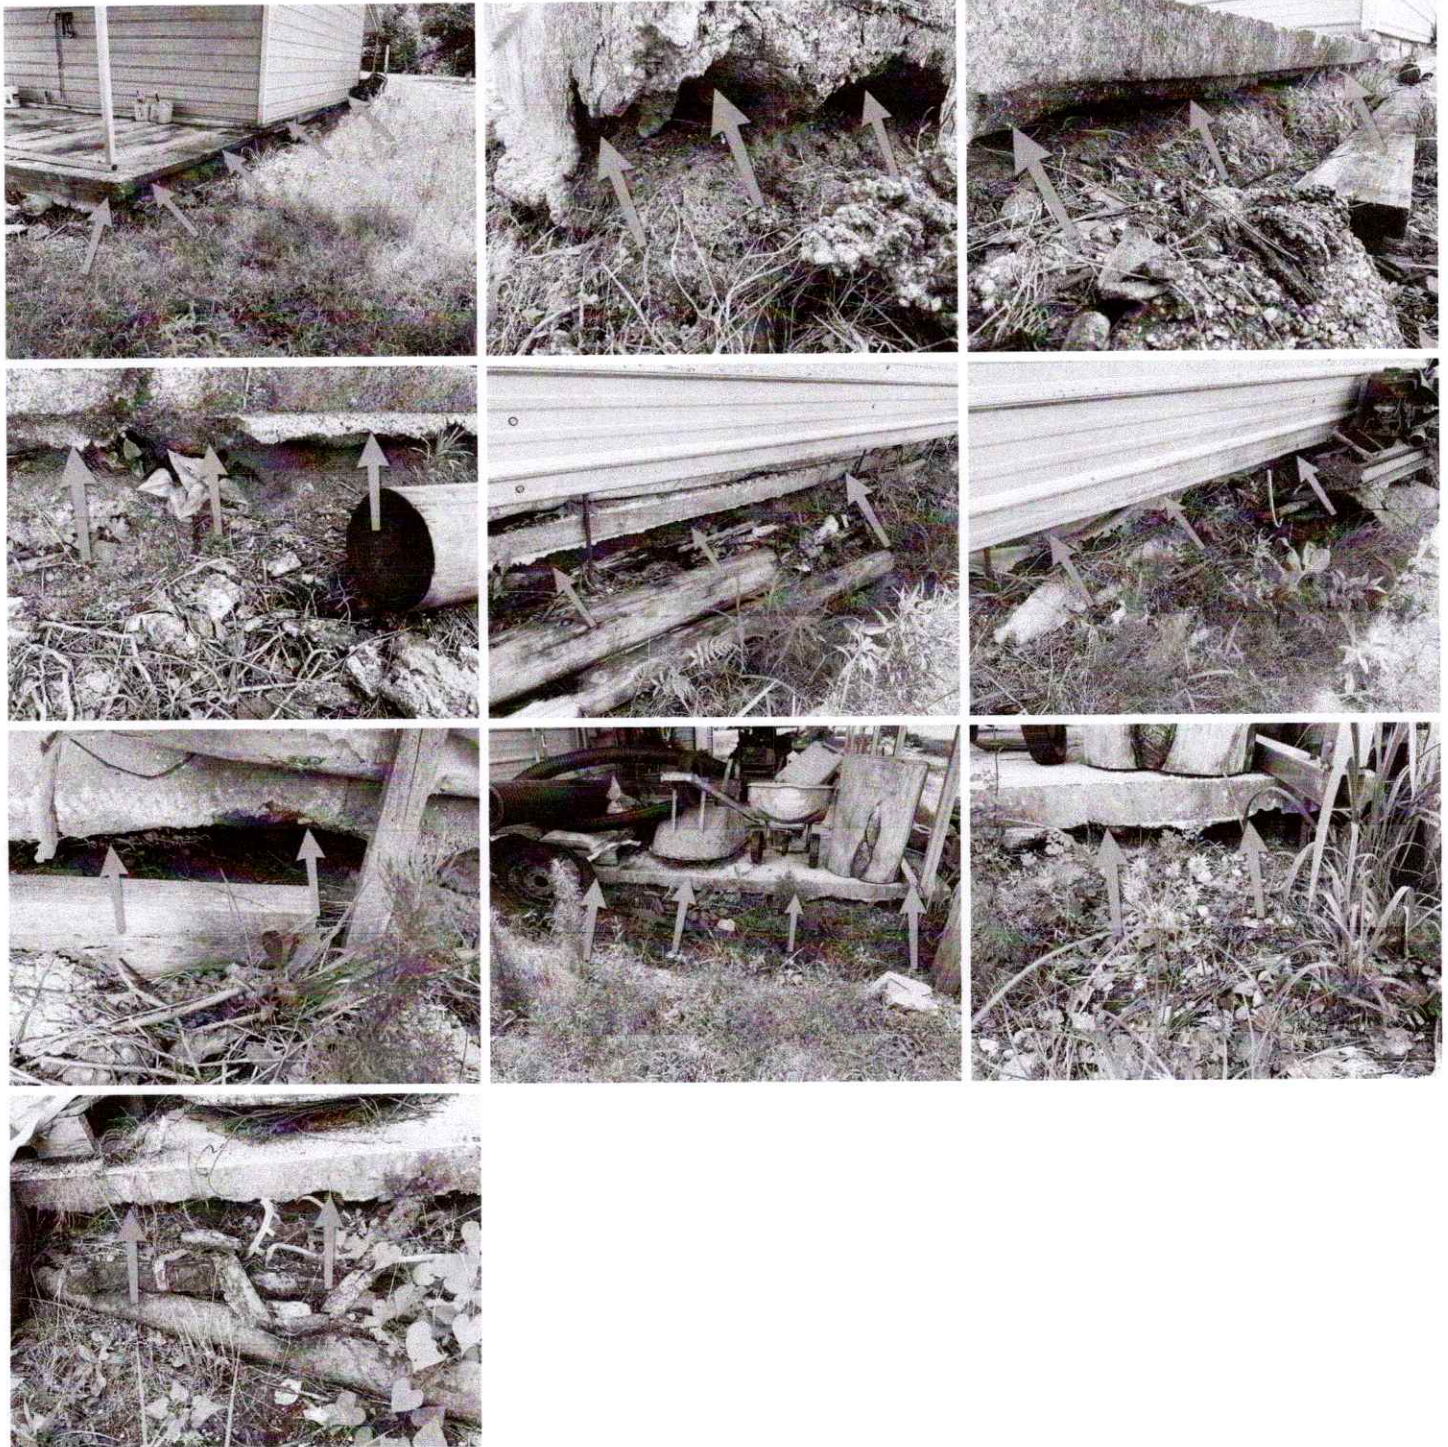
Signs of undermining were noted at the rear of the detached structure. Undermining refers to the erosion or removal of soil beneath a foundation or support structure, often caused by poor drainage, water runoff, or improper grading. This condition can compromise structural stability over time, potentially leading to settlement, cracking, or collapse of the affected area. Recommended repairs may include correcting drainage issues, regrading the surrounding soil, and reinforcing or rebuilding the undermined area with appropriate foundation support to restore stability.

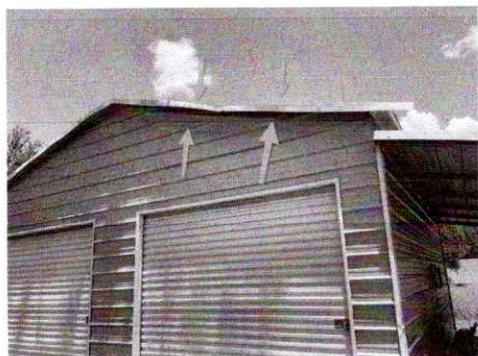
Dents/damage were located on the front and roof of the detached structure- the roof covering was unsecured as a result-recommend repair

Dent

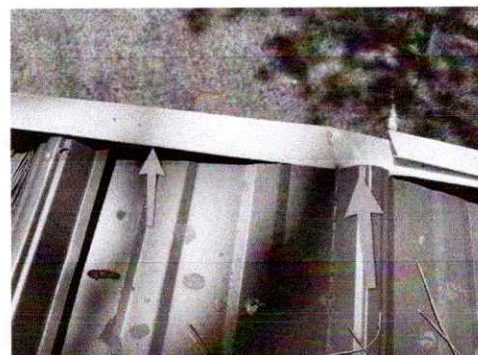
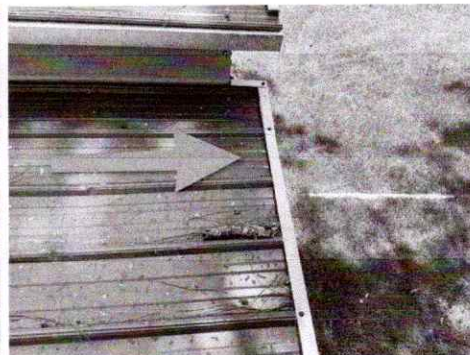
Missing screw here also

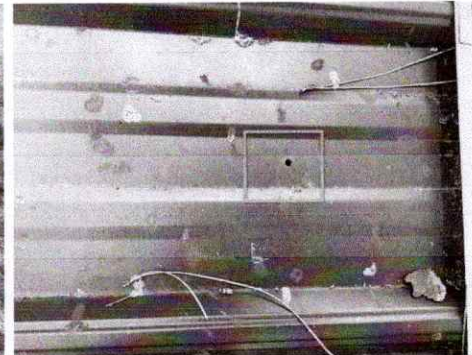
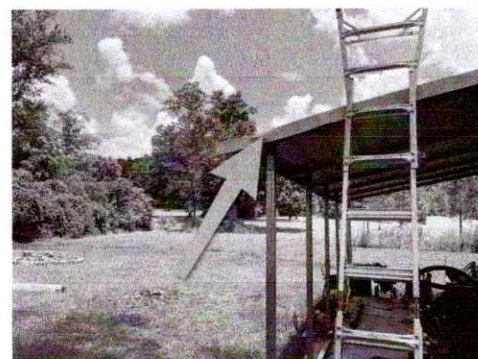
Dent here

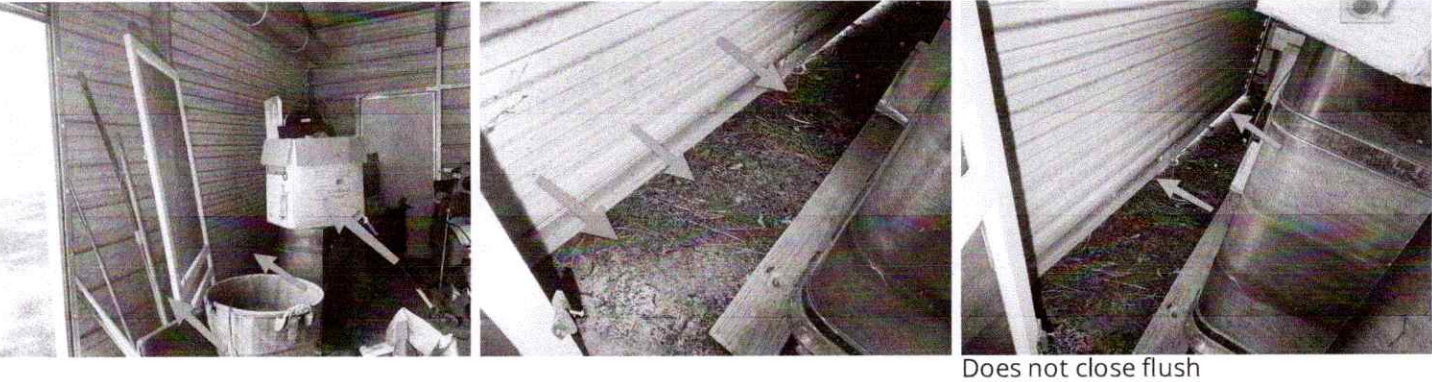
Evidence of water intruding under the rollup door in the detached structure was noted at time of the inspection. Evidence was based off of discoloration and staining here – recommend for the evaluation and repairs as needed.

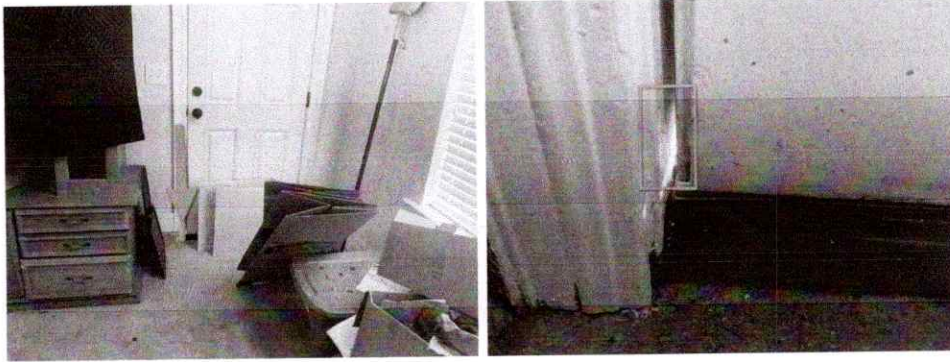
- Garage service/occupant service door has missing/damaged/ unsecured weatherstripping- recommend repair

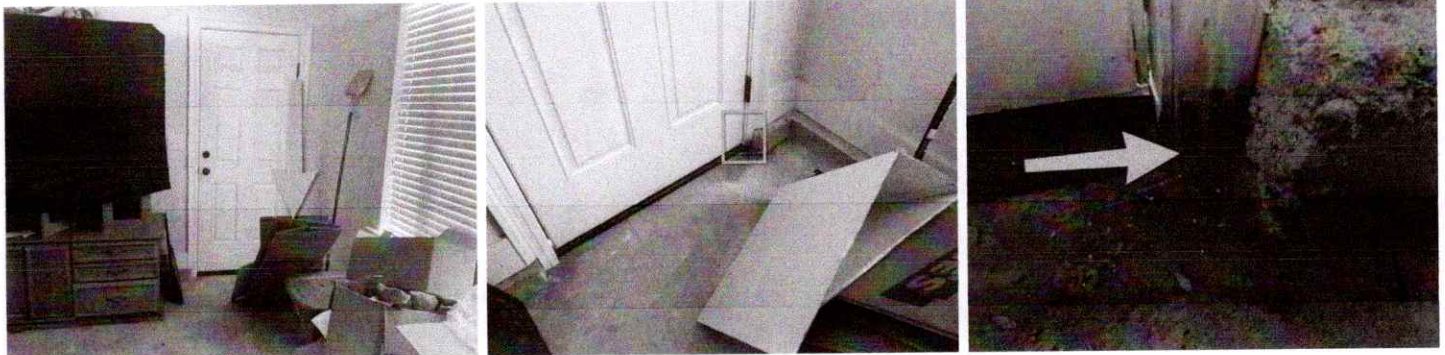
**Evidence of water intruding into the garage was located at door in garage that leads to the front yard. Evidence was based off of staining/discoloration- recommend further evaluation of this area and repairs as needed to prevent future intrusion.**

Evidence here

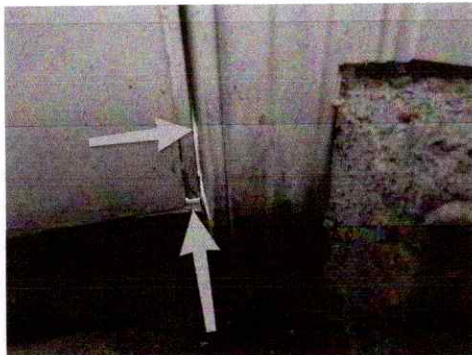
Water may be infiltrating here

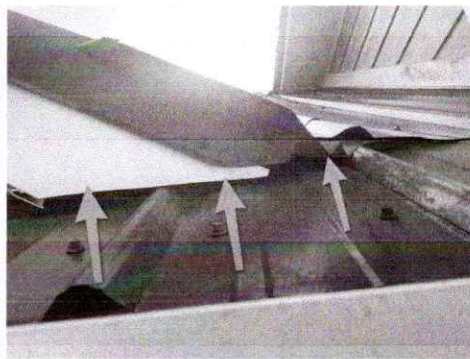
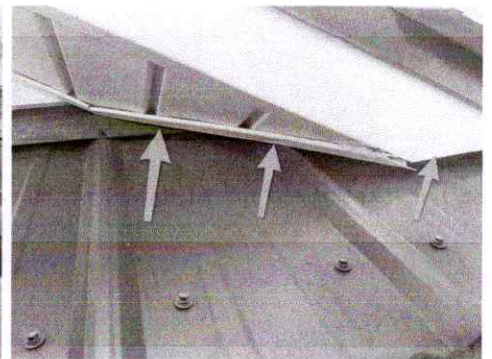
Left side of home

- Potential moisture/pest entry point/s into the home on roof structure- recommend repair/sealing.

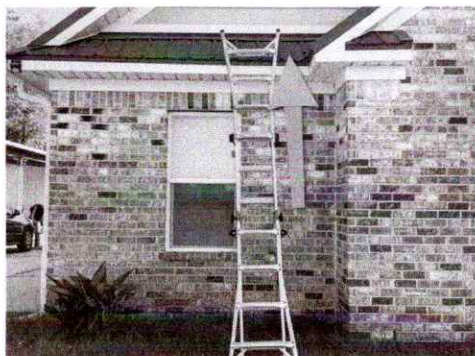
- Screws used to secure metal roof panels are missing and/or unsecured in areas, leaving roof improperly and inadequately secured and presenting water entry points-recommend repair by licensed roofer

Missing- Front of home

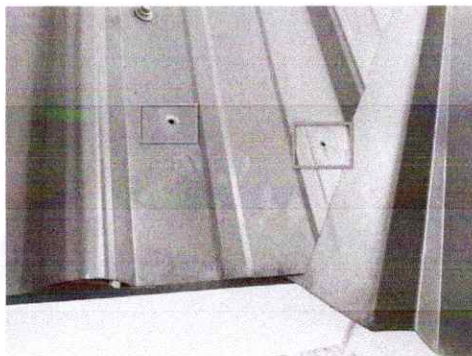
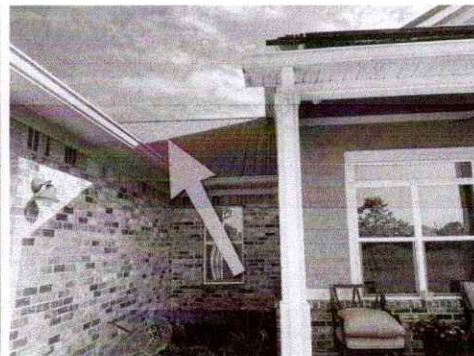
Unsecured- Front of home

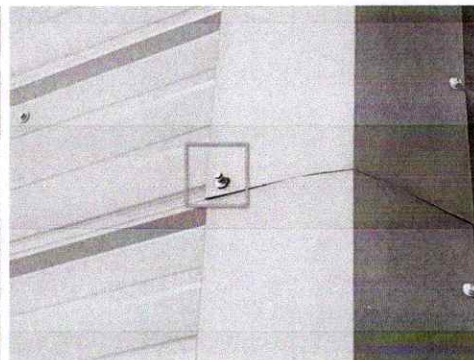
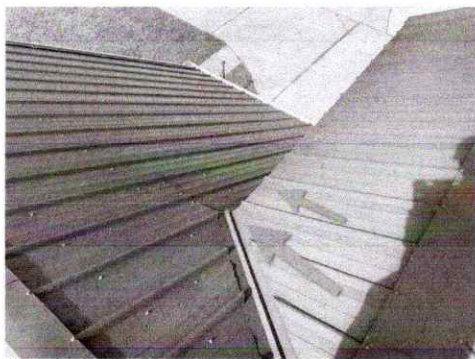
Missing- above garage

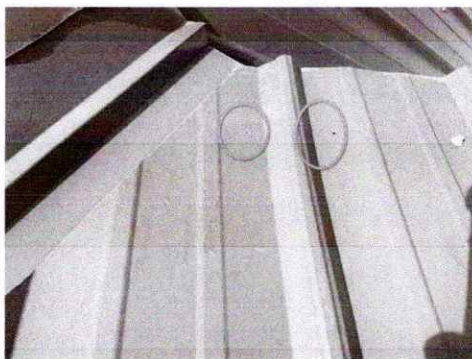
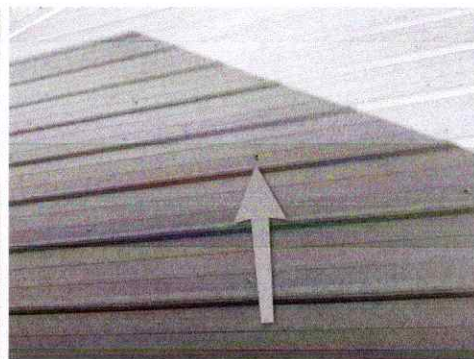
Unsecured- front of home

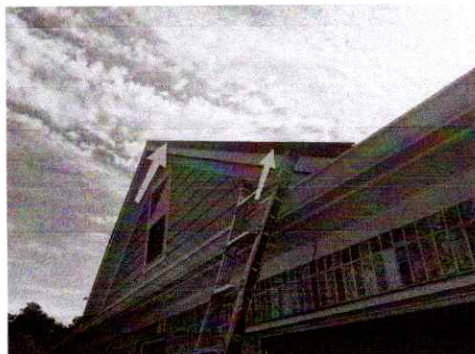
The drip edge flashing around the perimeter of the home was observed to be lacking screws or fasteners at appropriate intervals. Properly securing drip edge flashing is essential to ensure it remains in place during high winds and prevents water intrusion behind the fascia and into the roof decking. Missing or widely spaced fasteners may lead to separation, allowing moisture penetration, wood rot, and potential damage to the roof structure and exterior finishes. Recommend evaluation and correction by a licensed roofing contractor.

Only two screws

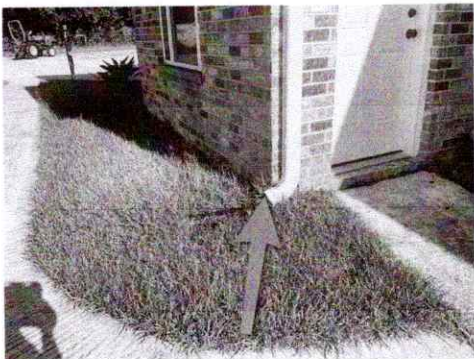
Front of home

- **One or more downspouts drain too close to the foundation. This can result in excessive moisture in the soil at the foundation, which can lead to foundation/structural movement. Given this areas high annual rainfall, water management is an important factor to consider and implement- Recommend adjusting downspout /adding extensions to drain at least 6 feet from the foundation.**

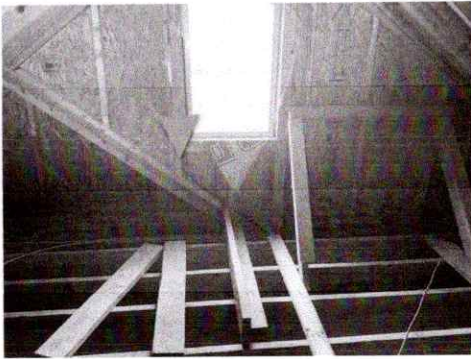
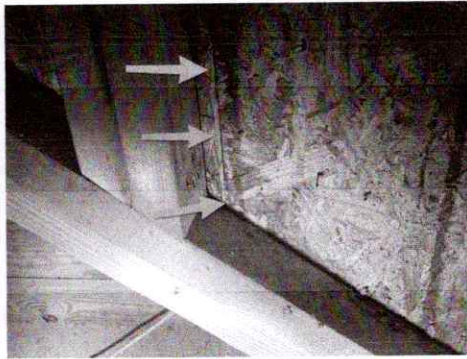
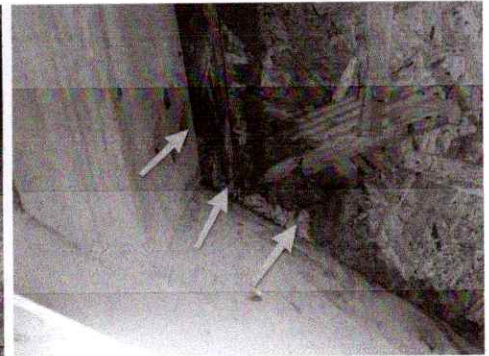
**WATER INTRUSION**

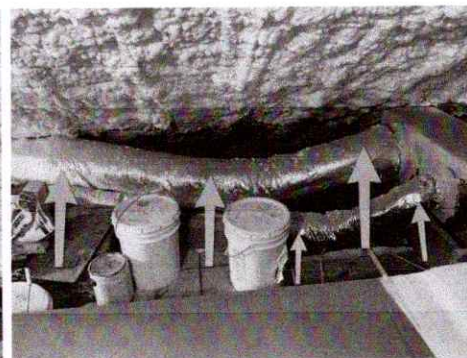
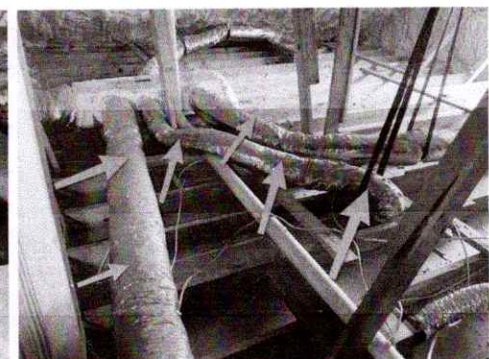
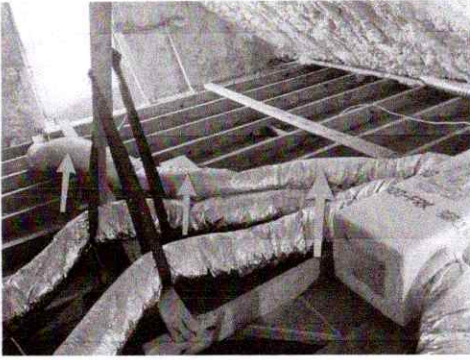
- One or more areas located in the attic where ductwork was installed/located along the rafters/beams- recommend adding bracing here so that ductwork does not make contact with the rafters/beams.

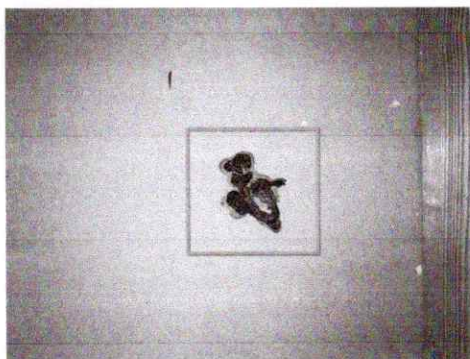
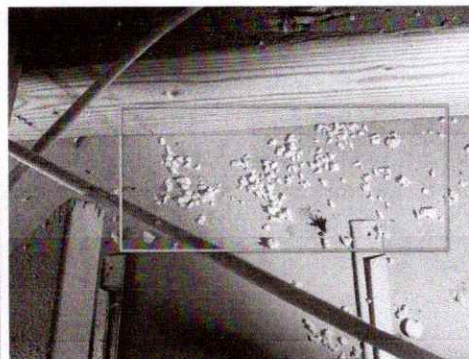
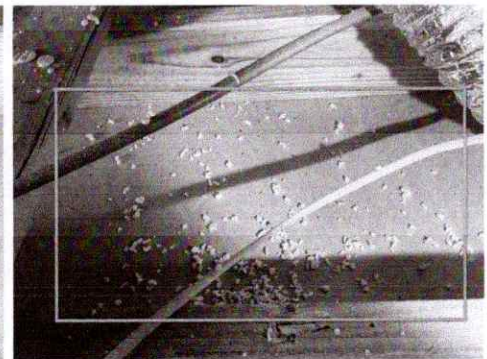
- Evidence of pests observed in the attic. Pests can contaminate the area and damage the framing, wiring and roof. Recommend pest removal and repair as needed by licensed pest service.

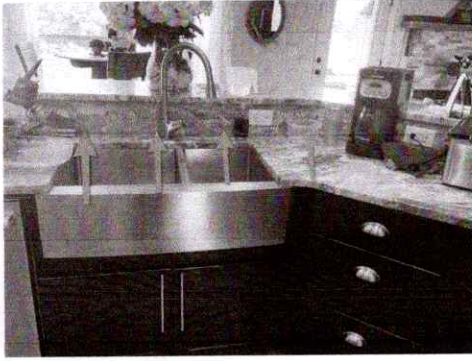
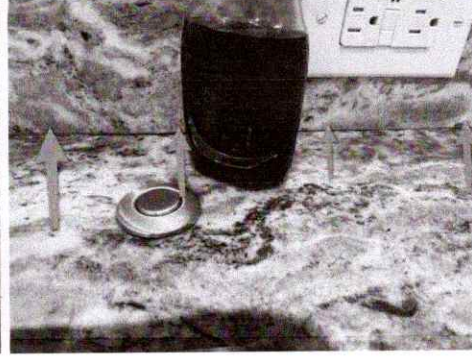
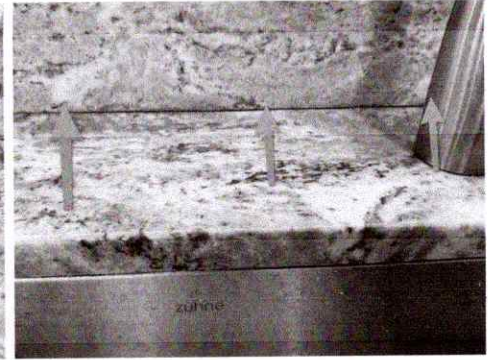
- Recommend additional caulking along the countertop, where required, to prevent food/liquids from infiltrating here- recommend repair.

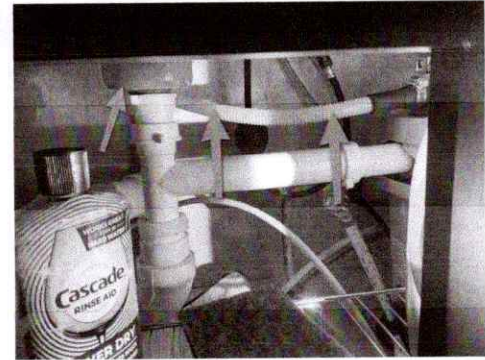
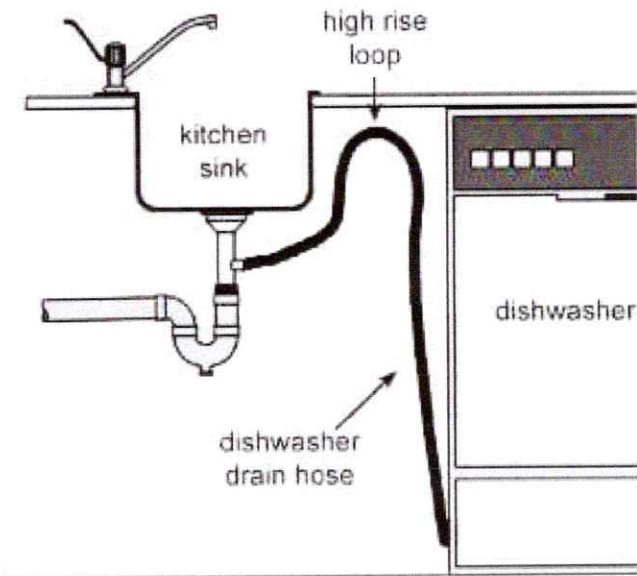
- Lack of a dishwasher "high loop" observed under the kitchen sink. A high loop prevents waste water back flowing from your sink to your dishwasher. If the drain hose is not elevated, there is a potential for water to run the wrong way through your drain hose and can cause standing water at the bottom of your dishwasher. Recommend repair.
