Docks On Old River Condominium  
16310 Perdido Key Dr  
Pensacola, FL 32507

Regarding: Docks on Old River Condominium – Phase I Milestone Inspection

**Docks On Old River – 2024 Phase 1  
Photo Log  
July 24, 2024**

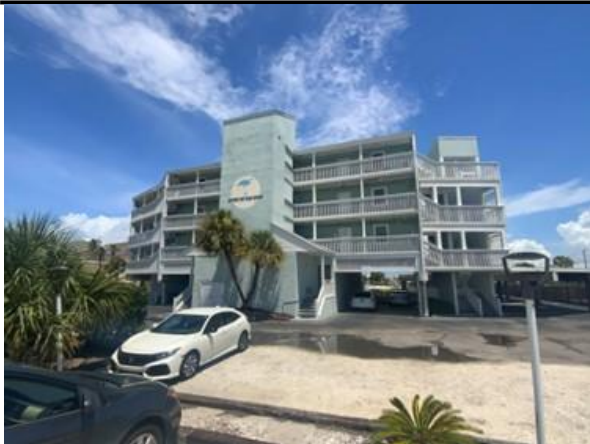
**Photo 1**  
Overall view of north elevation.

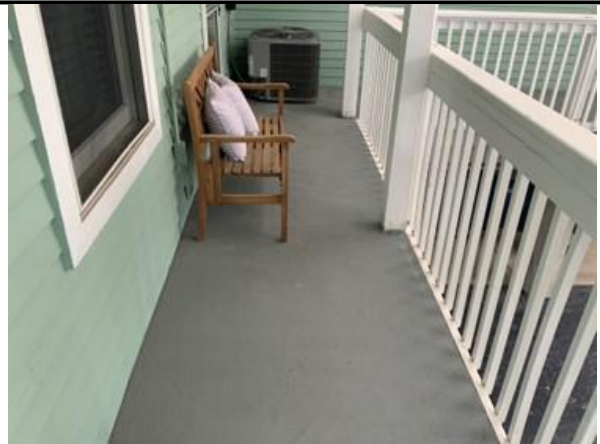
**Photo 4**  
View of common walkway.

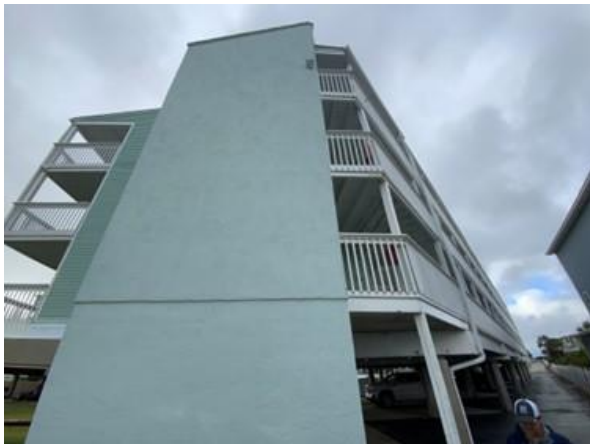
**Photo 2**  
Overall view of stucco cladding.

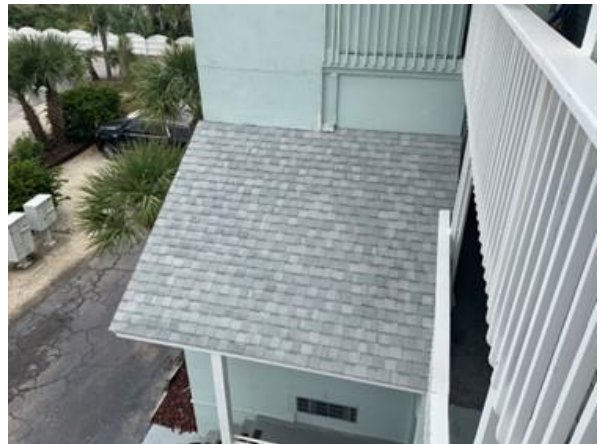
**Photo 5**  
View of roof in good condition.

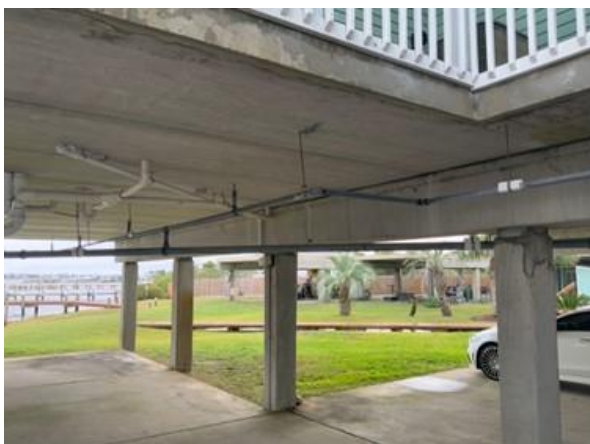
**Photo 3**  
Overall view of concrete columns in good condition.

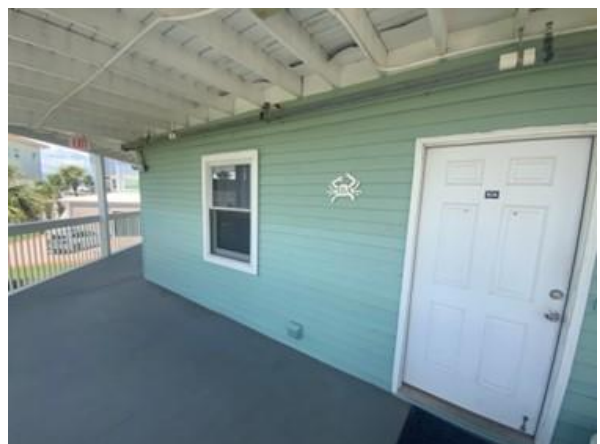
**Photo 6**  
View of unit entry doors and windows in good condition.

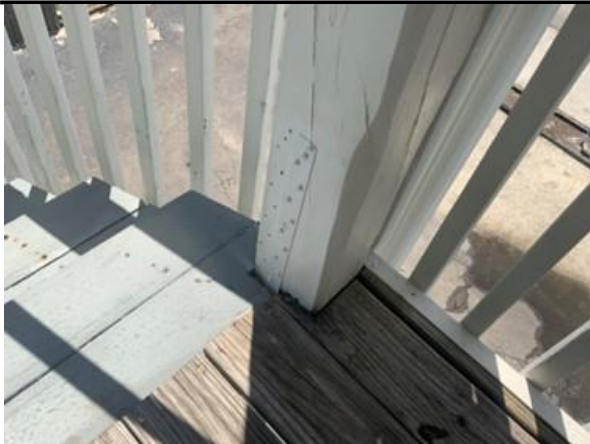
**Photo 7**  
View of hurricane straps in good condition.

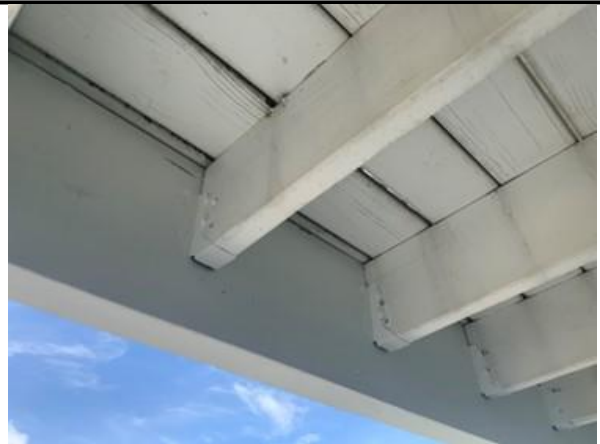
**Photo 10**  
View of hangars in good condition.

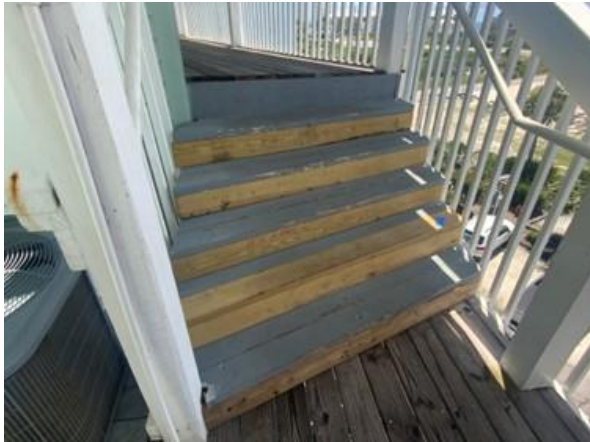
**Photo 8**  
View of wood stairs in good condition.

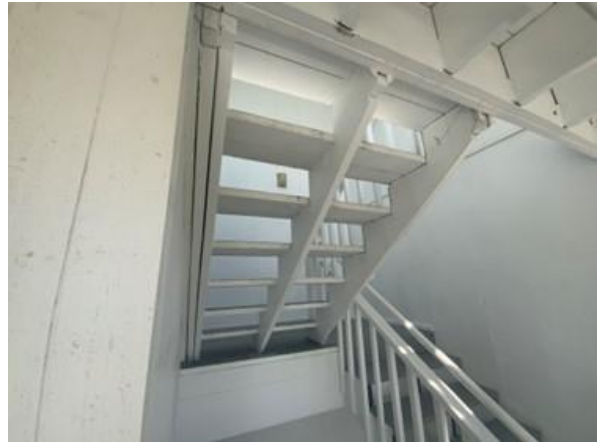
**Photo 11**  
View of wood stairs in good condition.

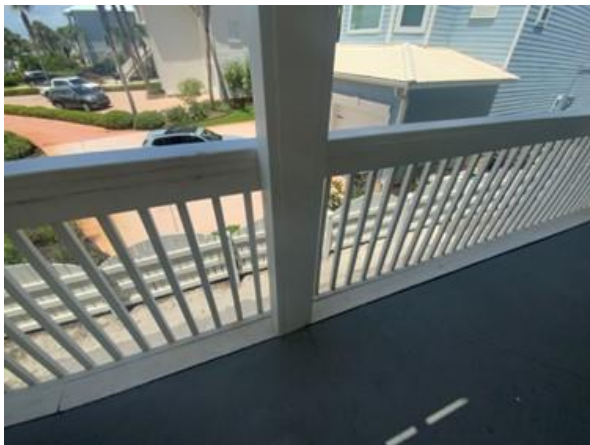
**Photo 9**  
View of handrails and columns in good condition.

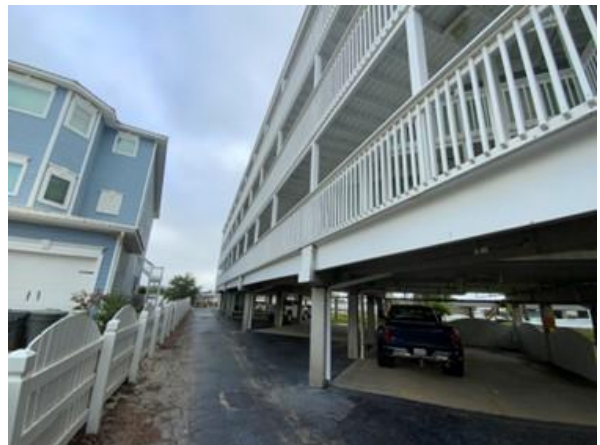
**Photo 12**  
Overall view of west elevation of building.

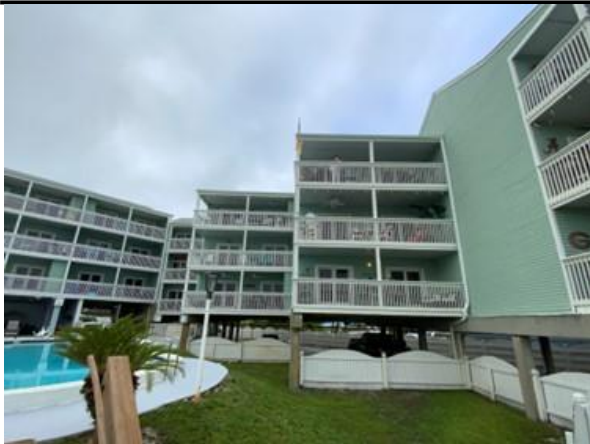
**Photo 13**  
Overall view of north elevation.

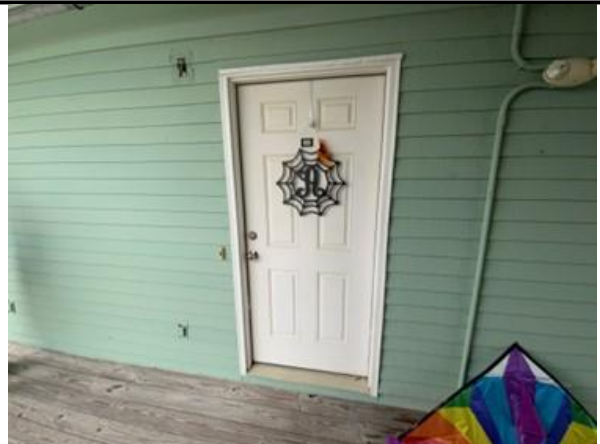
**Photo 16**  
View of unit entry door in overall good condition.

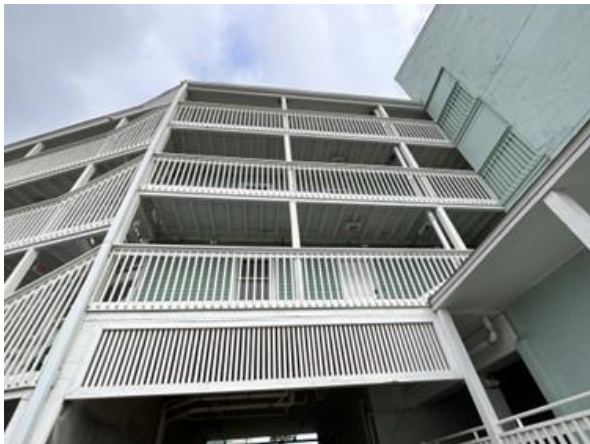
**Photo 14**  
View of handrails in good condition.

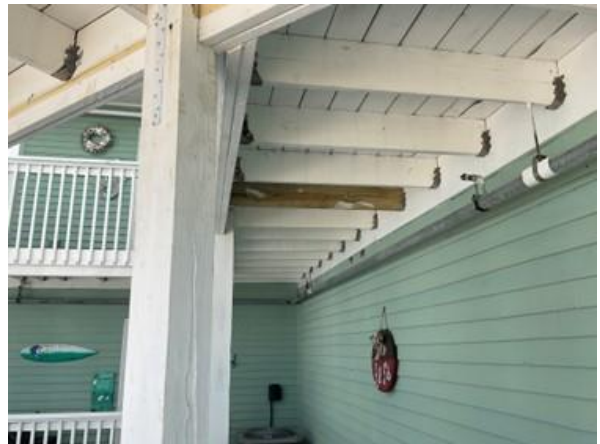
**Photo 17**  
View of vinyl siding in overall good condition.

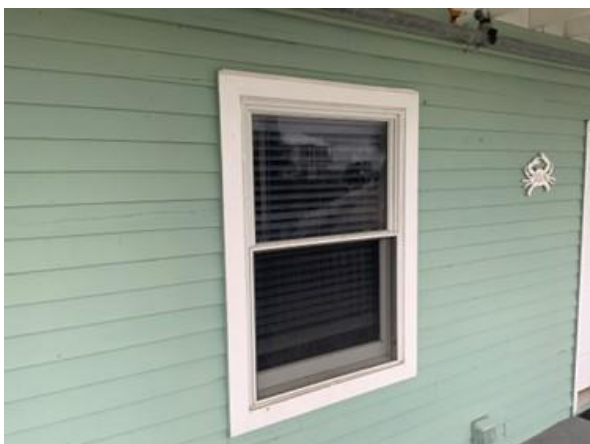
**Photo 15**  
View of exterior window in overall good condition.

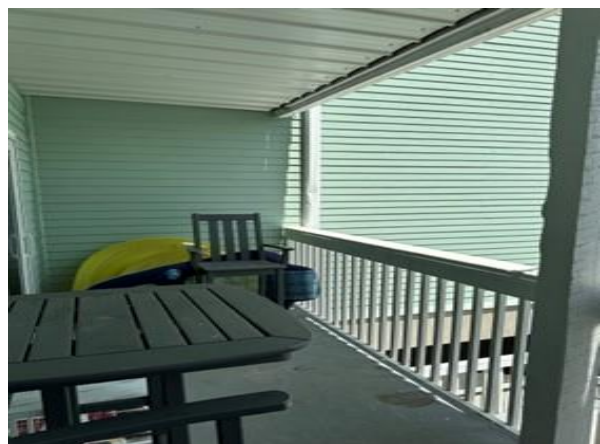
**Photo 18**  
View of balcony decking in good condition.

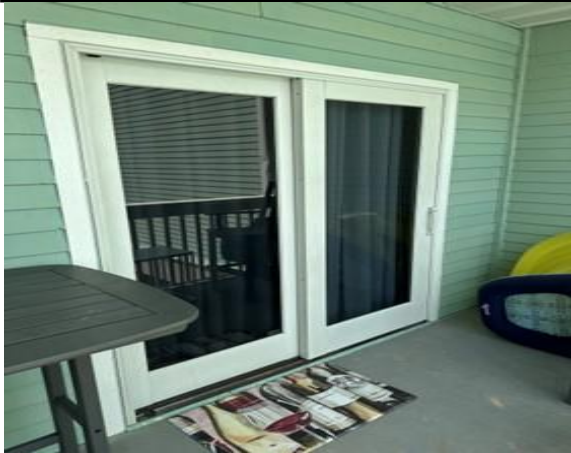
**Photo 19**  
View of balcony sliding glass door in good condition.

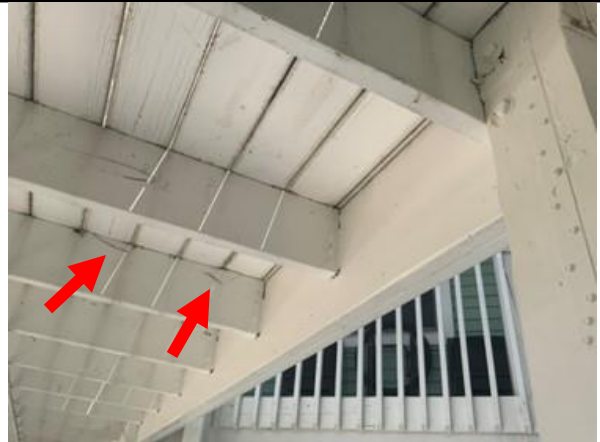
**Photo 22**  
View of isolated cracked joist at walkway.

- BECI found isolated corroded fasteners on the stair treads, isolated cracked deck boards, and isolated cracked joists during our time on site. ***BECI recommends that the corroded fasteners be replaced, and cracked joists and deck boards be repaired within the next one to two (1-2) years to prevent potential safety hazards.*** (Reference Photo Exhibit Nos. 20 through 22).
- At the South elevation elevator tower, the direct applied stucco was showing a rippling effect at the CMU walls indicative of moisture intrusion through the stucco system. ***BECI recommends sounding all of the direct applied stucco and repairing delaminated stucco during the next coating cycle to prevent potential detachment of the stucco.*** (Reference Photo Exhibit No. 23).

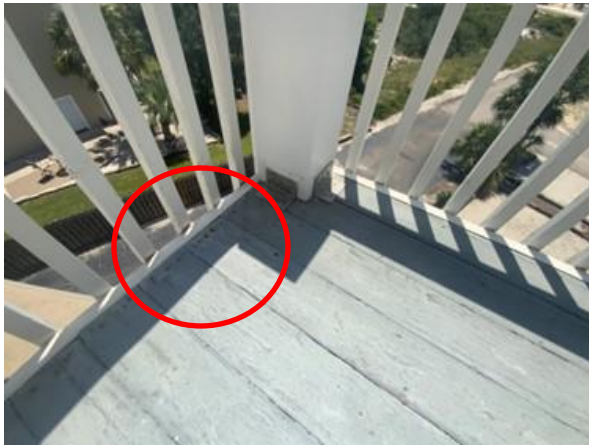
**Photo 20**  
View of isolated corroded fasteners at treads.

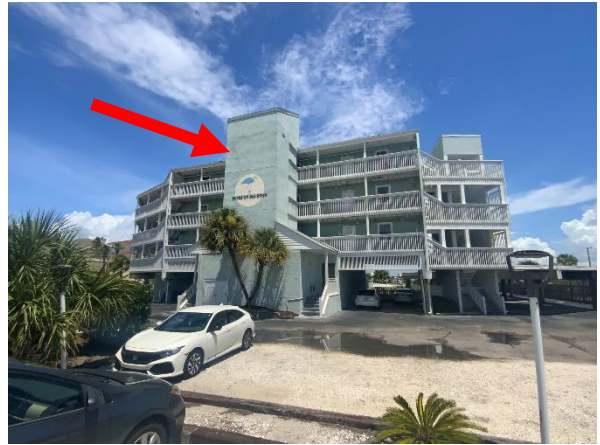
**Photo 23**  
View of rippling effect at direct applied stucco at elevator tower.

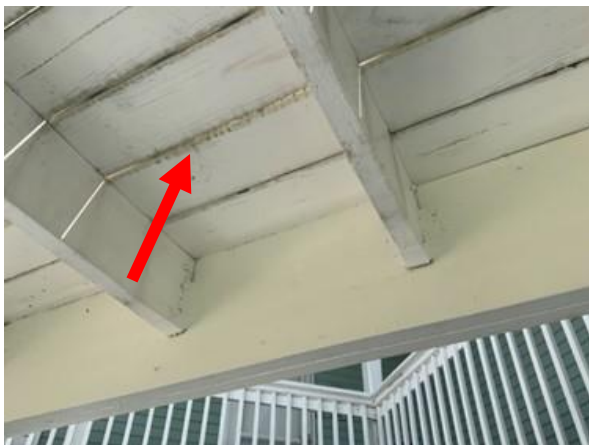
**Photo 21**  
View of isolated split deck board.
