HOME BOSS INSPECTION

## HOME BOSS PROPERTY REPORT

12094 Old Federal Rd  
Magnolia Springs, AL 36555

## 2: CRAWLSPACE

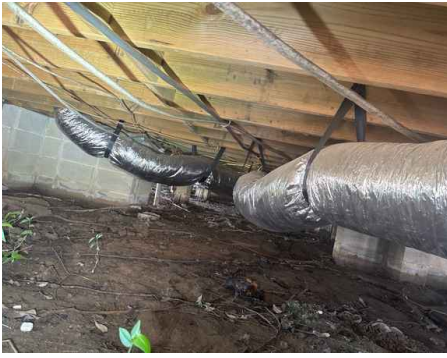
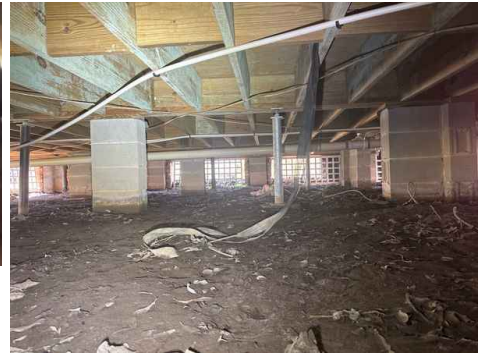
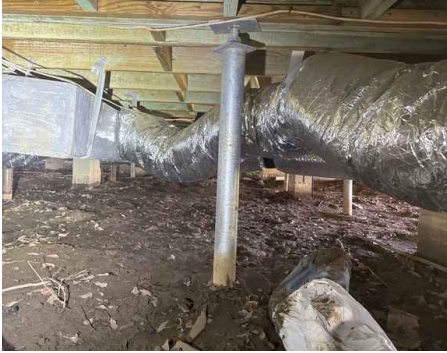
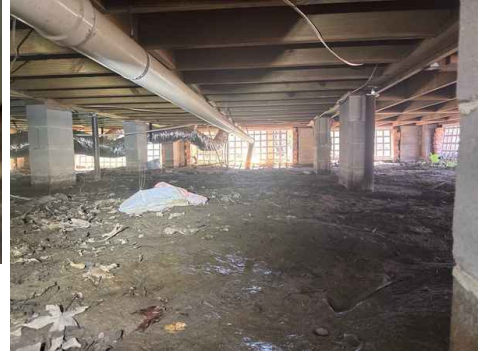
- Signs of microbial growth located on subfloor/other components in crawl space- although not uncommon in this part of a home, this could be due to condensation as a result of inadequate ventilation- recommend identifying source and cleaning these areas.

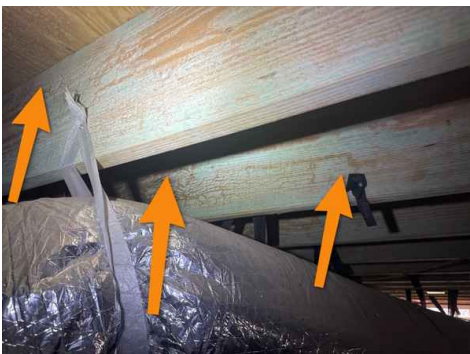
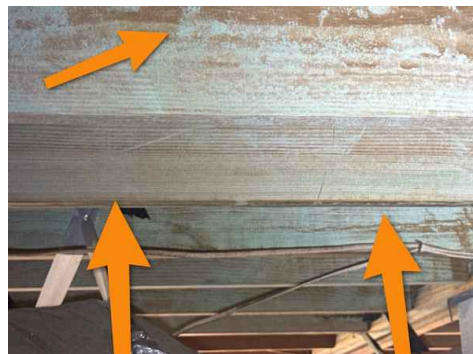
2.3.1 Sub-Floor/Joist/Beams

### SUB-FLOOR/MICROBIAL GROWTH

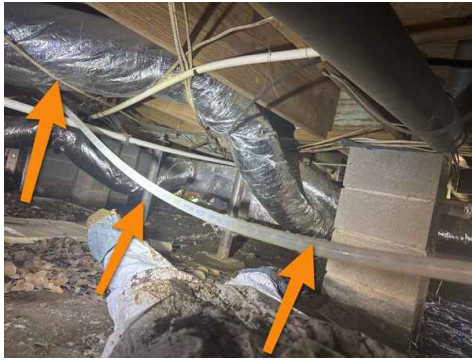
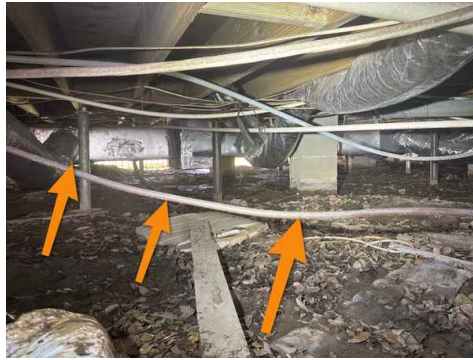
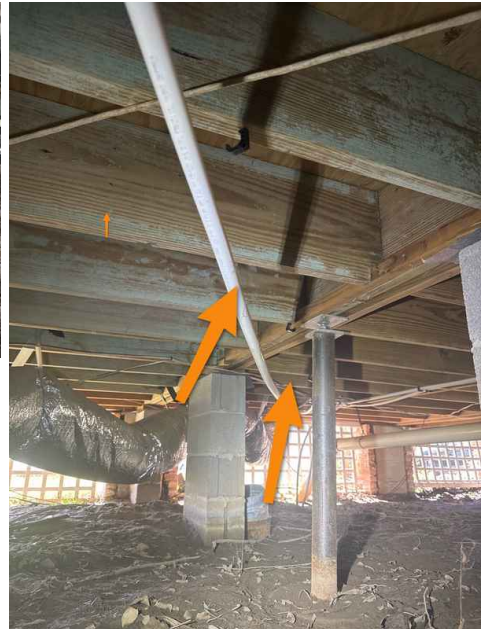
## 2.4.1 Plumbing/Gas Lines

**PLUMBING/GAS LINES-BRACING**

- **Recommend adding additional bracing where required to plumbing and/or gaslines located in the crawl space to prevent sagging and to alleviate stress on these lines- recommend repair.**

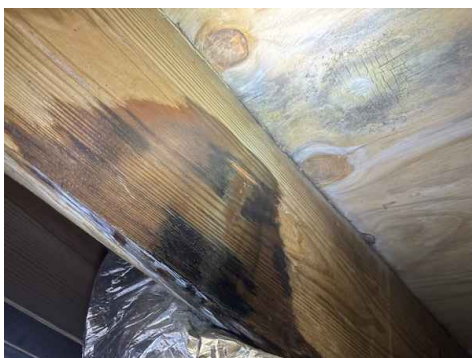
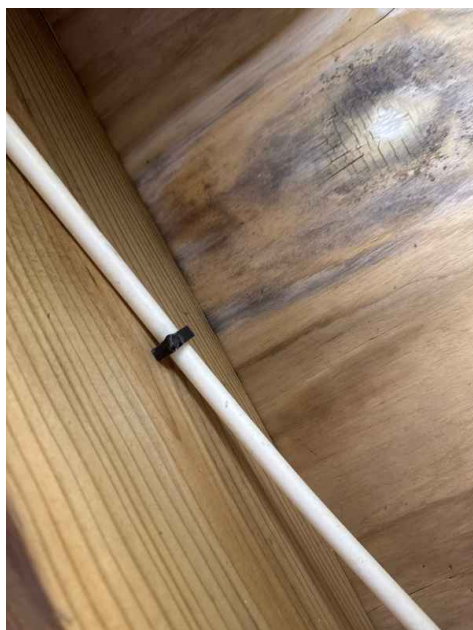
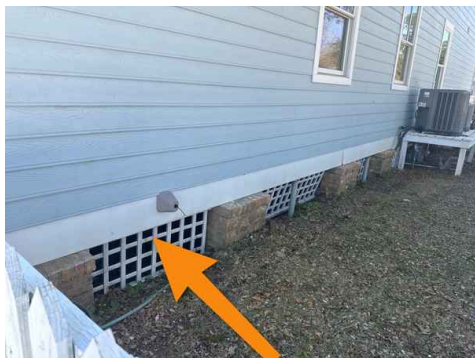
## 2.4.2 Plumbing/Gas Lines

**LEAK/DRIP-PLUMBING LINES**

- **Leak/dripping observed at one or more plumbing pipes located in crawl space- recommend further evaluation and repairs as needed by licensed plumber.**

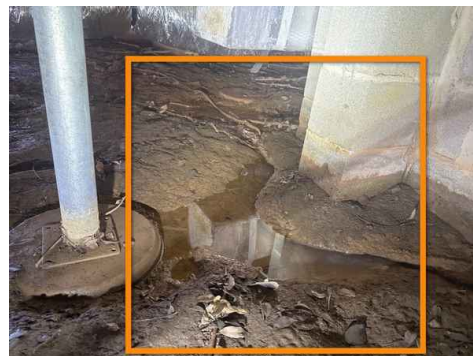
## 2.6.1 Vapor Retarders

**STANDING WATER**

There was standing water and the ground in the crawl space was wet- although a sump pump was installed, the sloping around the perimeter of the crawl space, is likely what needs to be addressed- recommend repair

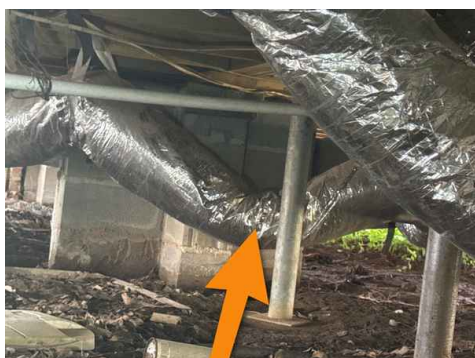
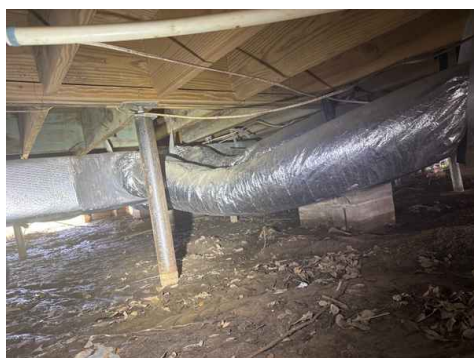
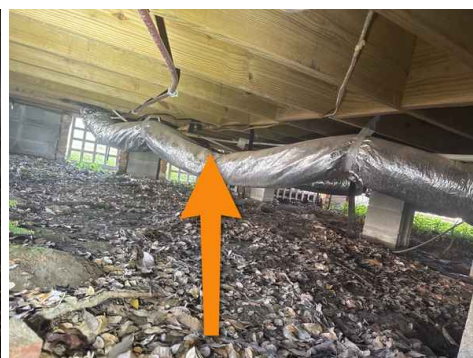
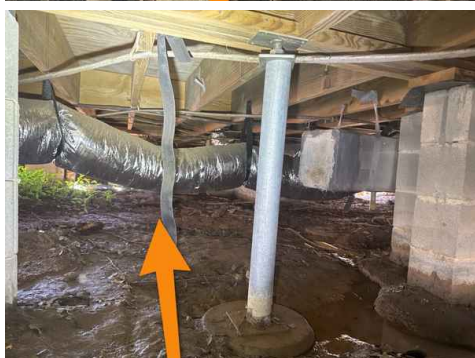
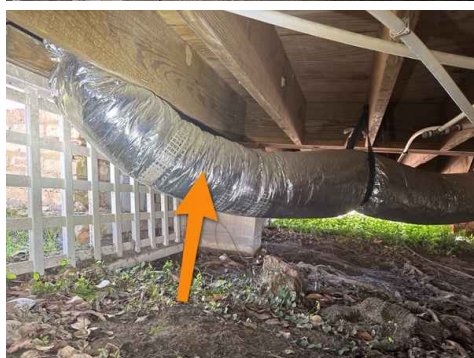
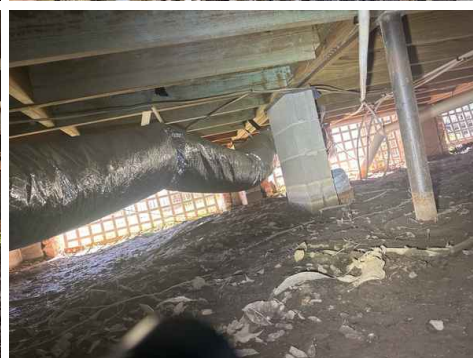
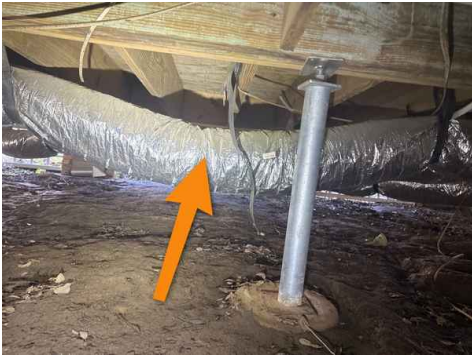
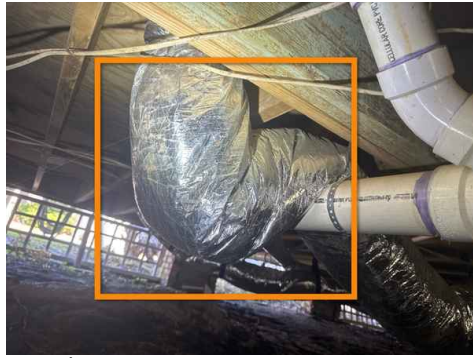
## 2.8.1 Ductwork

**DUCTWORK SAG**

- One or more areas located in crawl space where ductwork is sagging which could allow for the accumulation of condensation inside the ductwork, which not just adds weight to ductwork which can cause it to fall, but can also reduce the HVAC efficiency - recommend repair by licensed HVAC service.
