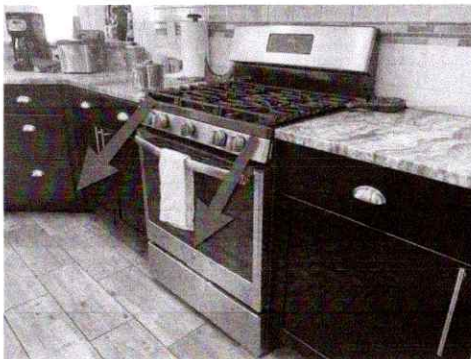
**RANGE: ANTI-TIP: MISSING**

- The range was not equipped with an anti-tip bracket, which can allow/cause range to tip forward- this is a potential safety hazard- recommend repair. These are installed on its rear/back footing.

**Anti-tip brackets**

These are used to secure the range to the wall or floor to prevent tipping over and causing serious injury

with anti-tip bracket secured

without anti-tip bracket secured

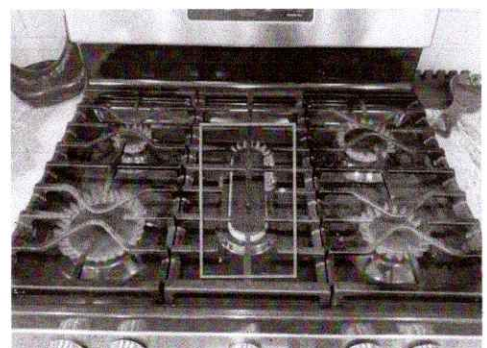
**RANGE BURNER/S -INOPERABLE**

- One or more burners to range in kitchen not operating at the time of the inspection- recommend repair.

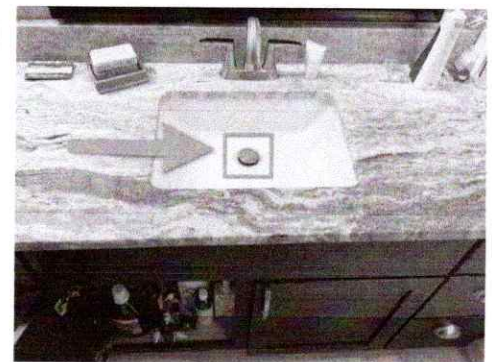
Sink to your right

#### **SINK - POOR/MARGINAL DRAINAGE**

- Drainage from sink in this bathroom, was marginal/poor at the time of the inspection- recommend repair by licensed plumber.

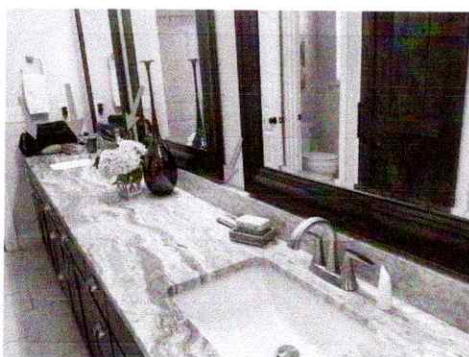
#### **CAULKING- ADDITIONAL REQUIRED**

- Additional caulking in this bathroom is recommended where required- recommend repair.

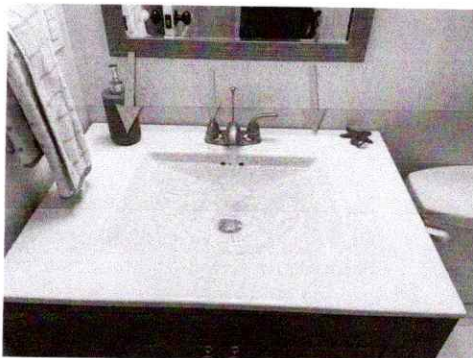
**CAULKING- ADDITIONAL REQUIRED**

- Additional caulking in this bathroom is recommended where required- recommend repair.

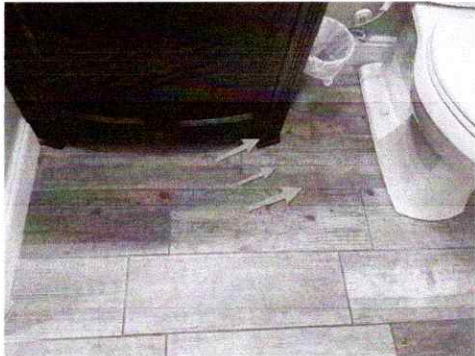
**FLOORING- CRACKED/DAMAGED**

- **Damaged and/or cracked flooring located in one or more area's- recommend repair by licensed flooring service.**

Cracked tile here

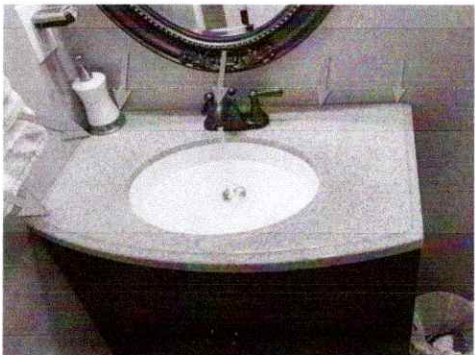
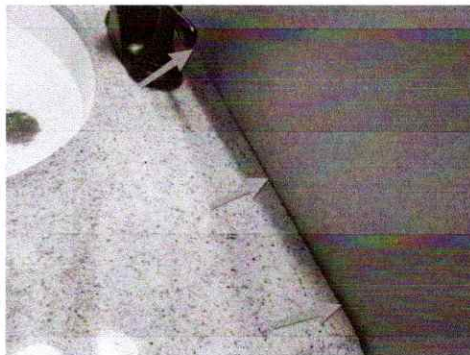
**CAULKING- ADDITIONAL REQUIRED**

- **Additional caulking in this bathroom is recommended where required- recommend repair.**

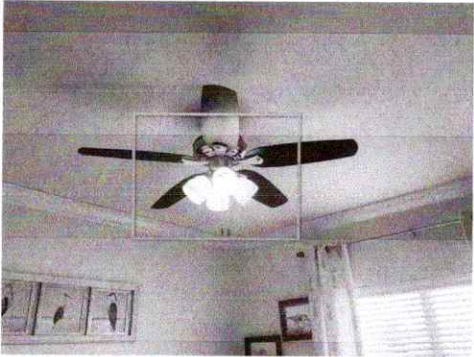
**CEILING FANS/-INOPERABLE**

- **Ceiling fan/s in this room was not operating at the time of the inspection-** recommend repair/replacement by licensed & insured electrician.

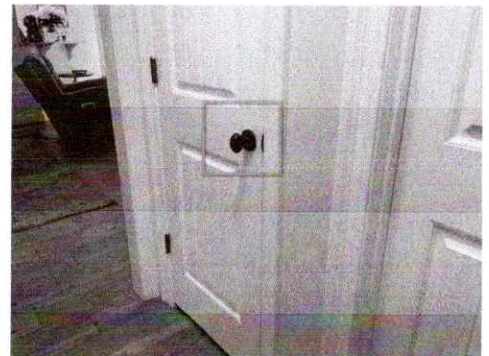
**DOOR -DOES NOT CLOSE/LATCH**

- Door /s located in this room do not properly close/shut/latch-recommend repair.

Closet door in hallway does not latch

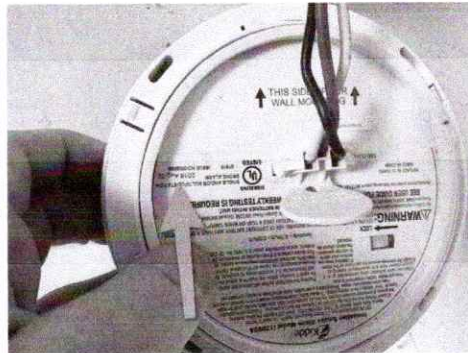
Smoke detectors will expire next year

It is recommended that smoke detectors are replaced at least every 10 years. Batteries are required/recommended be replaced at least every 6 months. Recommend smoke alarms in & outside every sleeping room, and on every level of the home.

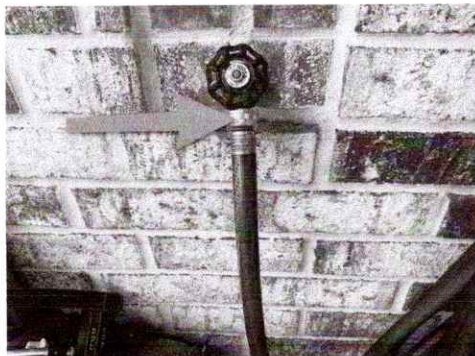
Rear of home

#### **FAUCET-NO ANTI- SIPHON**

- **Exterior faucet/s not equipped with anti- siphon device/s. These device's/valve's prevent contaminated water from entering a clean water supply - recommend repair .**

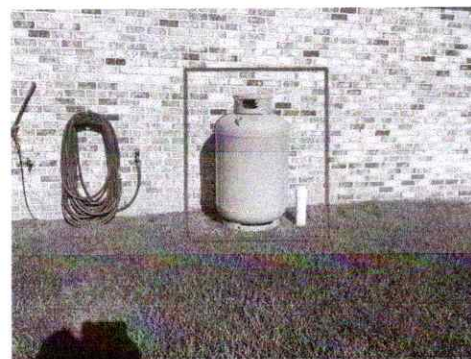
**GAS SUPPLY- CLOSE PROXIMITY /HOME**

- Gas tank /supply was installed within close proximity of the home. This is considered a potential fire/safety hazard as gas tanks contain flammable gases, that can ignite if exposed to open flames, sparks or heat. The minimum distance required is 10 feet for small tanks (125 gallons or less) but tanks that are larger require further distance – recommend repair.

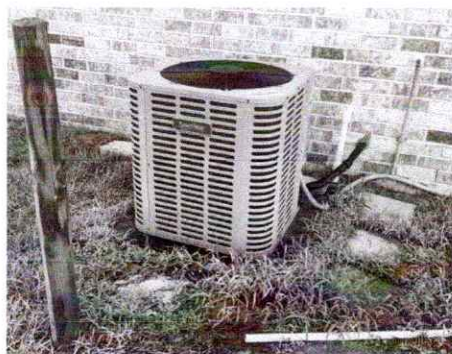
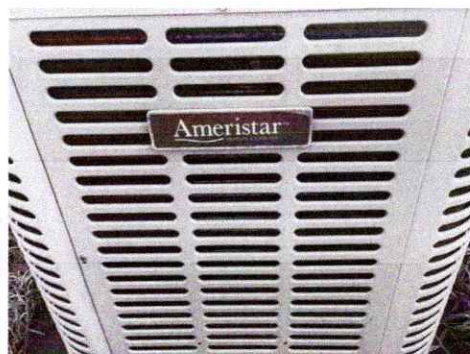
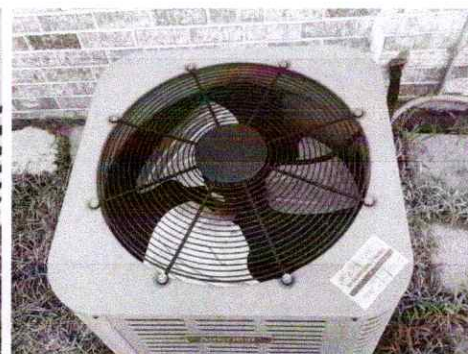
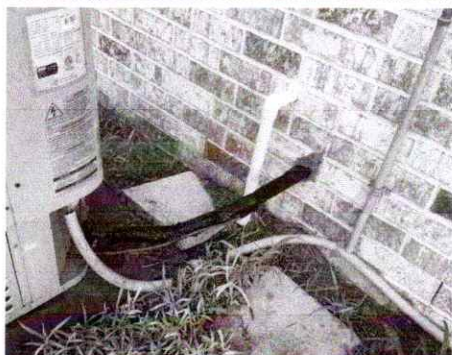
#### Exterior A/C- Cooling: General Photos

#### Exterior A/C- Cooling: Condition

Satisfactory

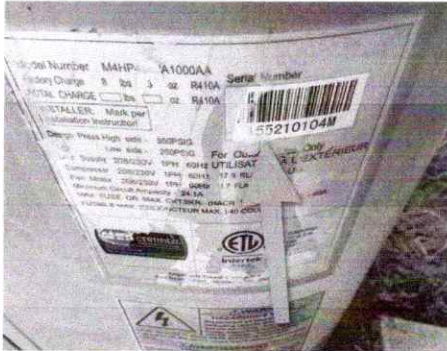
**Exterior A/C- Cooling: Approximate Age**

Original to the home, 10 Years

These units typically have a lifespan of 10-15 years, depending on factors that contribute to the service life of these components. These include, but are not limited to the location of the unit, climate and preventative maintenance.

Unit was manufactured in the 52nd week of 2015

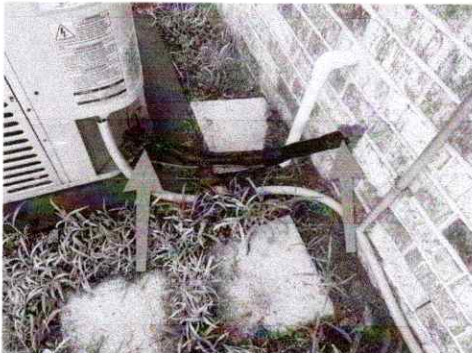
**Recommendations****21.1.1 Exterior A/C- Cooling****INSULATION - MISSING/DAMAGED/DETERIORATED****EXTERIOR A/C UNIT**

- Missing, damaged, or deteriorated insulation on refrigerant line was observed. This can cause energy loss and condensation. Recommend repair.

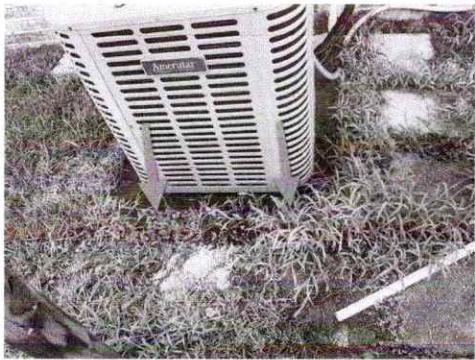
**21.1.2 Exterior A/C- Cooling****TIE DOWNS/STRAPPING****EXTERIOR A/C UNIT**

- Strapping/tie downs, typically installed on bottom of the exterior A/C unit, securing it to its pad/platform, was not present/installed- recommend repair.

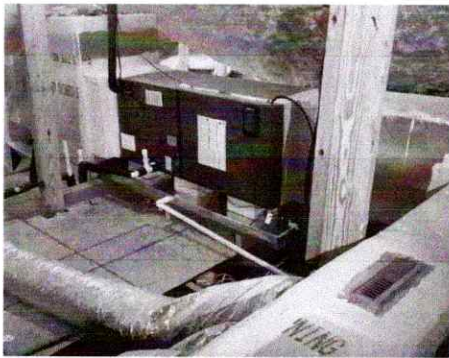
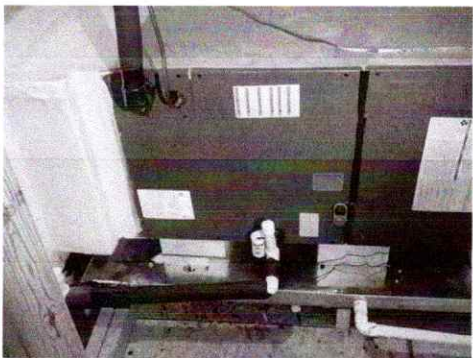
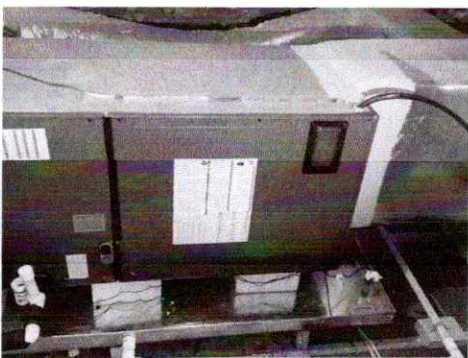
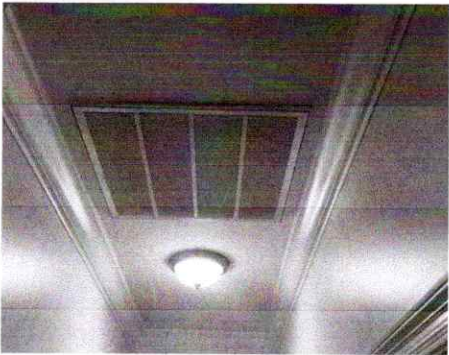
**Furnace-Heat: General Photos**

**Furnace-Heat: Condition**  
Satisfactory

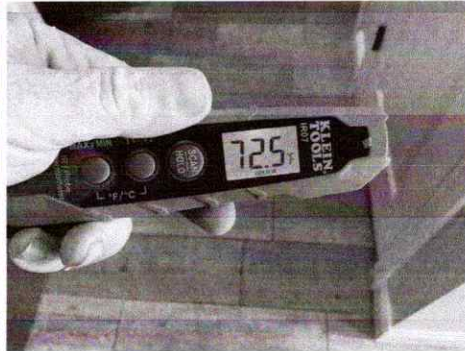
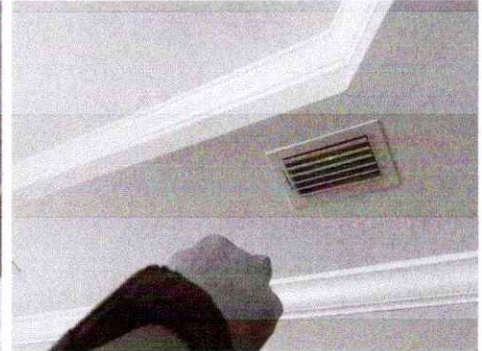
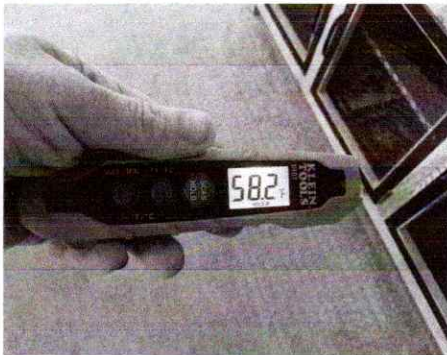
## Furnace-Heat: Operation

Air temperature differential reading was 14

As part of our assessment of the HVAC system, we do what is called an "air temperature differential" reading. This includes taking a temperature reading at the furnace return and a reading of the air released at the vents, which should show a temperature differential reading of 13-20 degrees, which invariably means the unit operated/cooled as it should.

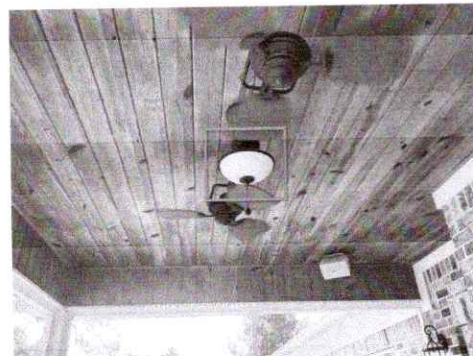
**LIGHT/S -INOPERABLE- EXTERIOR/INTERIOR**

- Light fixtures (one or more) were inoperable on exterior/interior of the home, at the time of the inspection. This could be due to a burned out or missing bulb or a mechanical failure in the switch or the fixture. Most likely new light bulbs are needed, though it is impossible to test if electric works until they're replaced.
- If replacing the bulb does not correct the problem, a licensed electrical contractor should evaluation if new light bulb doesn't turn on after bulb is in place.

Light never did turn on

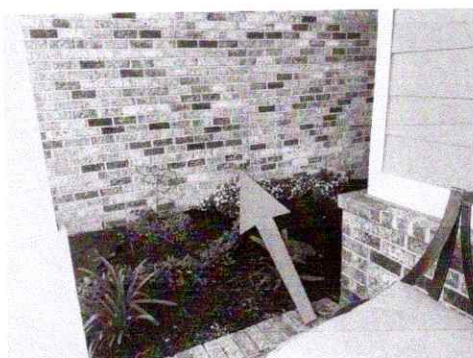
Front of home

- One or more exterior GFCI outlet/s do not reset, rendering them/it inoperable at the time of the inspection-recommend repair by licensed & insured electrician.
