**Re:     *Flagged Wetland Assessment***  
          ***19330 County Road 68, Baldwin County, AL***  
          ***WSI Reference #2023-654***

As requested, Wetland Sciences, Inc. has completed a field wetland assessment of the above-mentioned property located at 19330 County Road 68 in Section 8, Township 5 South, Range 4 East in Foley, Baldwin County, Alabama. The Baldwin County Property Appraiser identifies the subject property by the following property identification numbers: 619400. This assessment included an analysis of plant communities, soils, and indirect hydrologic indicators. During this determination, Wetland Sciences, Inc. identified a wetland complex subject to the regulatory jurisdiction of the US Army Corps of Engineers (Corps) Baldwin County within the subject property (See attached wetland sketch – **Exhibit A**). The following is a summary of our findings.

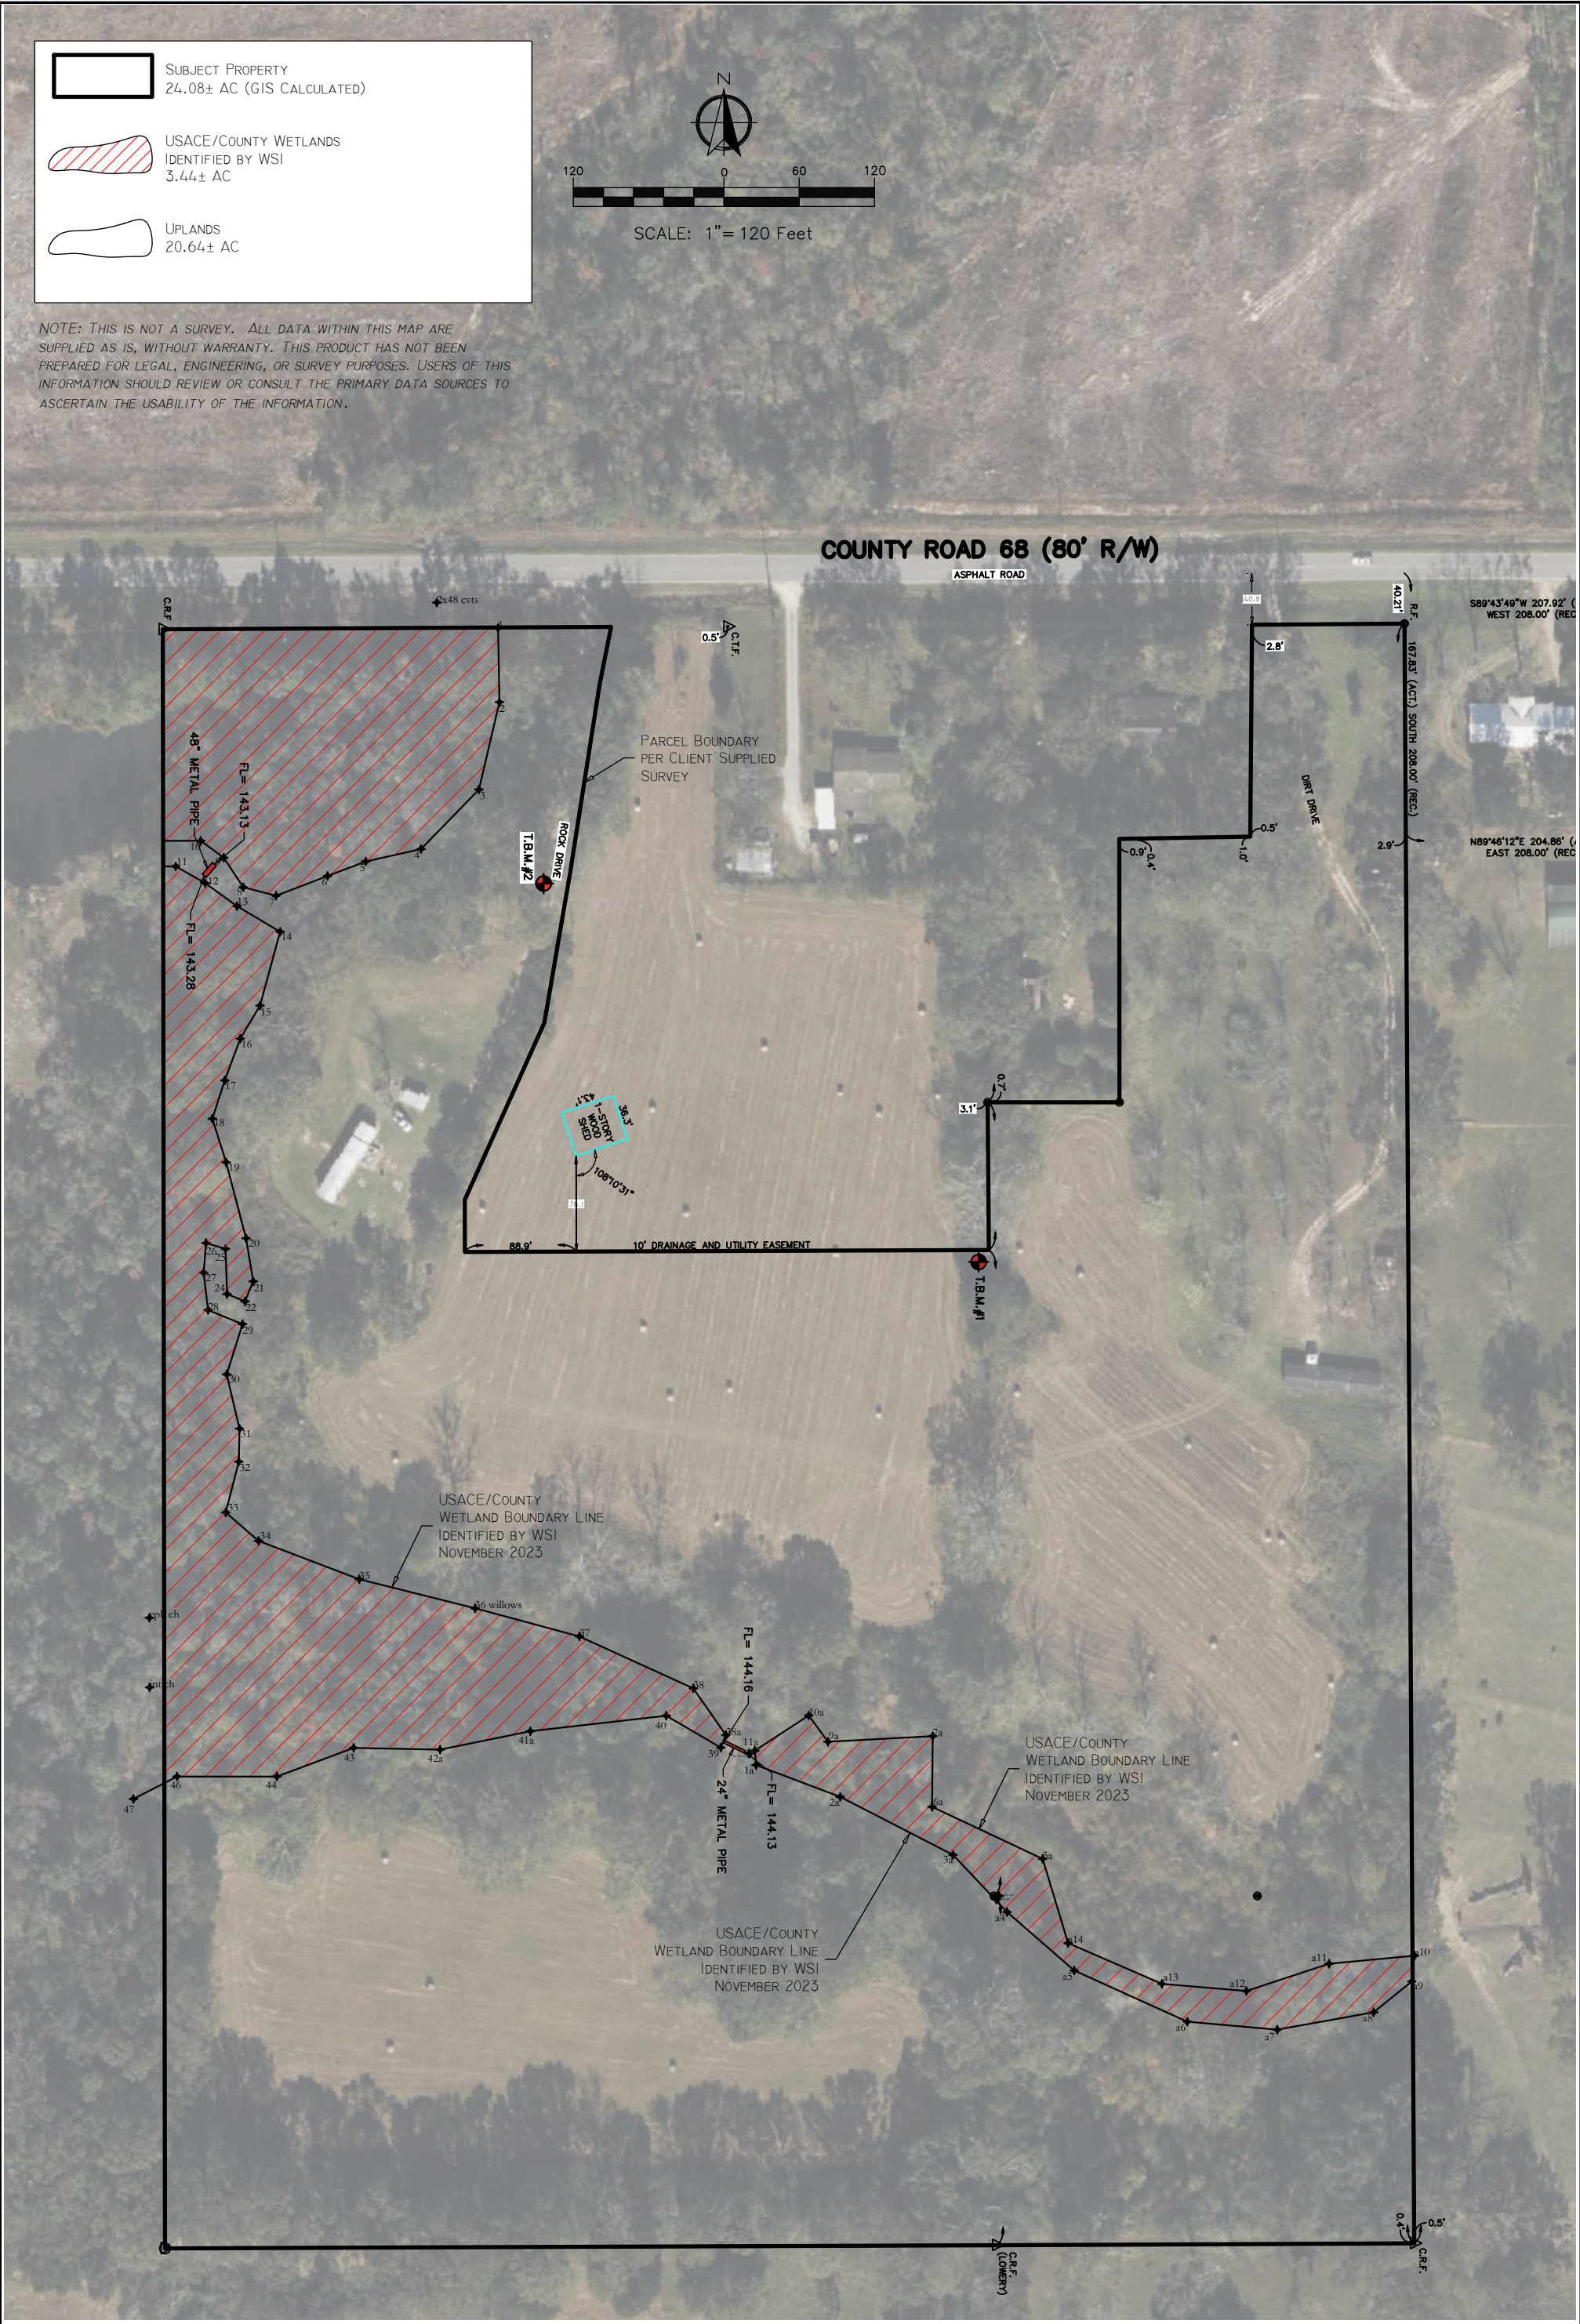
SUBJECT PROPERTY  
24.08± AC (GIS CALCULATED)

USACE/COUNTY WETLANDS  
IDENTIFIED BY WSI  
3.44± AC

UPLANDS  
20.64± AC

The assessment was completed by a thorough pedestrian survey covering 100% of the subject property. I personally inspected the property on October 30, 2023, and November 2, 2023. The wetland boundaries shown on the attached sketch were delineated in accordance with the Regional Supplement to the Corps of Engineers Wetland Delineation Manual: Atlantic and Gulf Coastal Plain Region (Federal – Corps). The wetland boundary was identified in the field by progressively locating points along the upland/wetland boundary at 15-20-ft. intervals or corresponding with directional changes with the boundary. Each point was identified and located by an experienced wetland scientist. Pink flags were placed at each point clearly marked “Wetland Delineation”. Each flagged point also contains specific alpha numeric designator for later tracking of its location. Wetland Sciences, Inc. used a Trimble Geo7x GNSS system to locate each point. Data was collected using Trimble’s TerraSync Professional Software with further data refinement using Trimble’s Pathfinder Professional Software. Please keep in mind that there are many variables that affect the accuracy of the GPS data used to generate the attached sketch. This sketch should be considered approximate unless verified by a survey or other appropriate means.
