August 12, 2025

Subject: Wetland Determination  
Lot 2, Jennifer Moore Merritt Subdivision  
Ferry Road Circle (PIN:304659)  
Fairhope, Baldwin County, Alabama

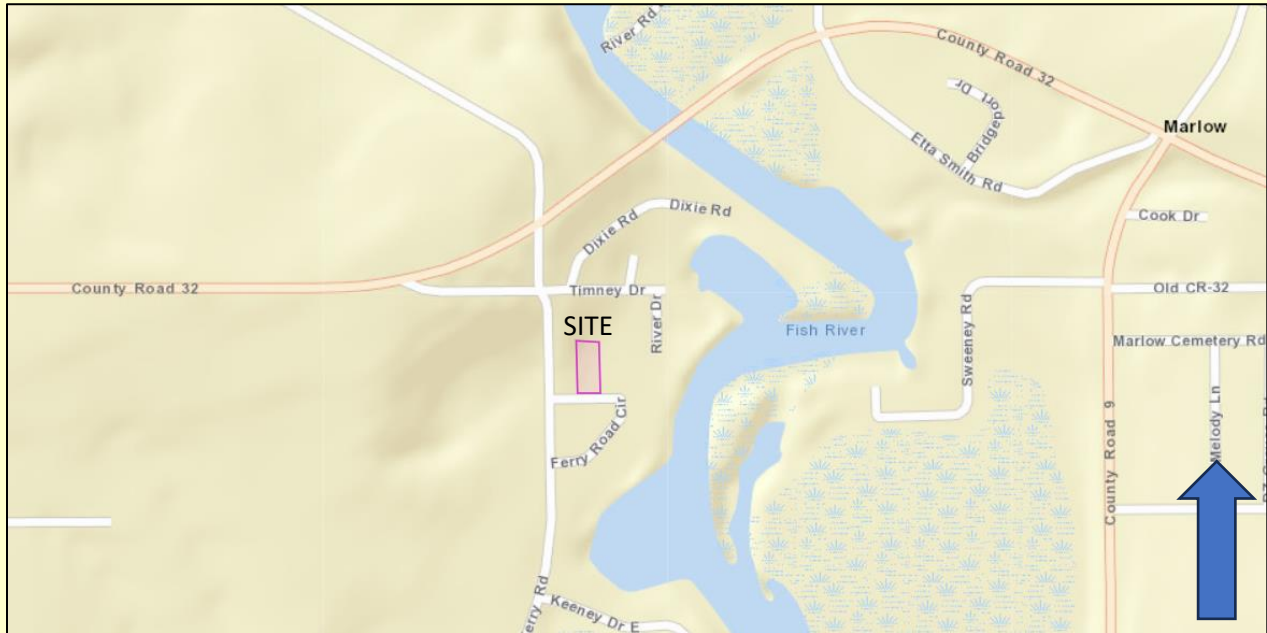
## Location Maps

Lot 2, Jennifer Moore Merritt Subdivision  
Ferry Road Circle (PIN:304659)  
Fairhope, Baldwin County, Alabama  
30.471291, -87.804007
