## HOME BOSS INSPECTION

### HOME BOSS PROPERTY REPORT COPY

21573 Co Rd 68 N  
Robertsdale, AL 36567

06/21/2025

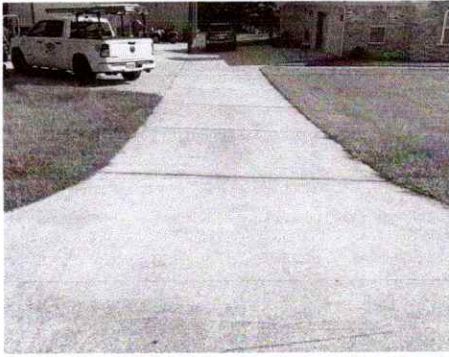
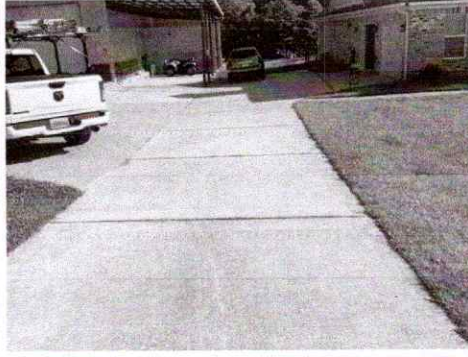
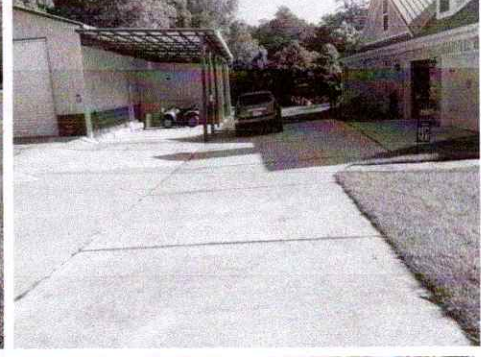
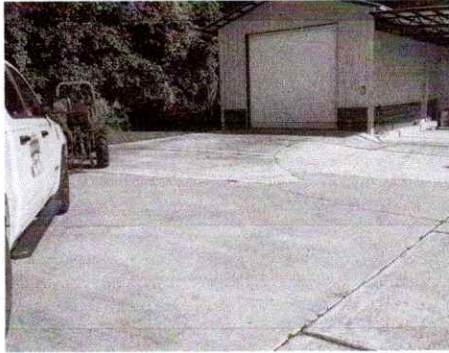
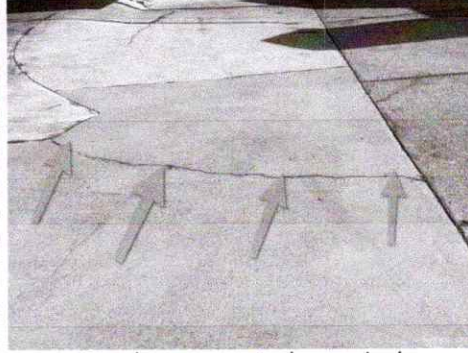
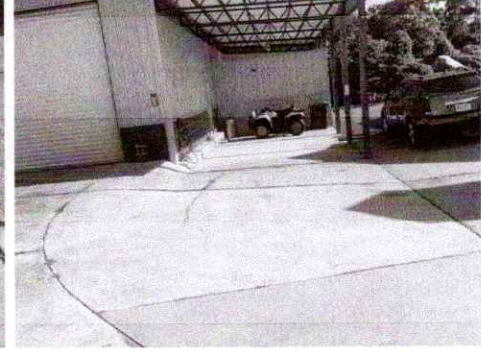
## Walkways/Driveways: General Photos

Cracks appear to be typical

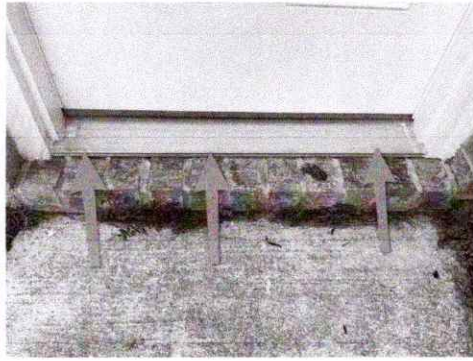
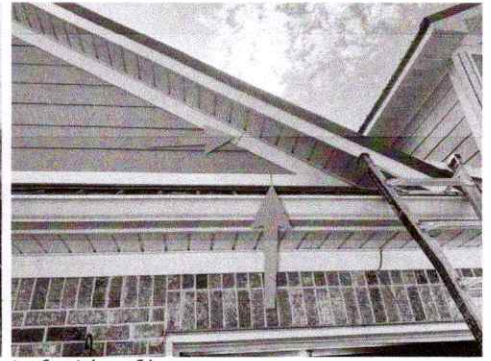
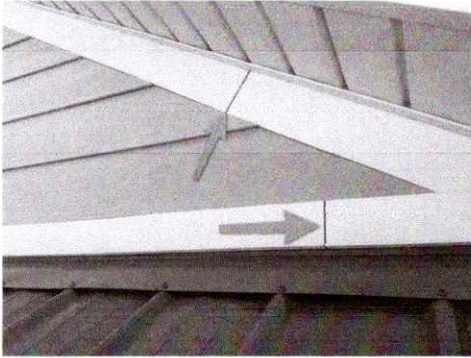
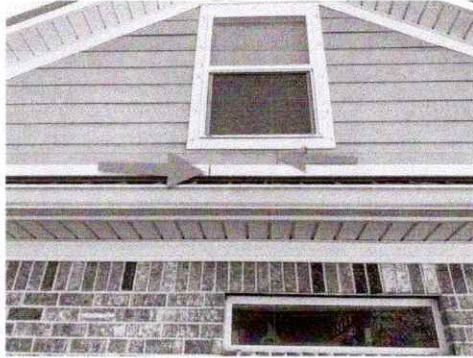
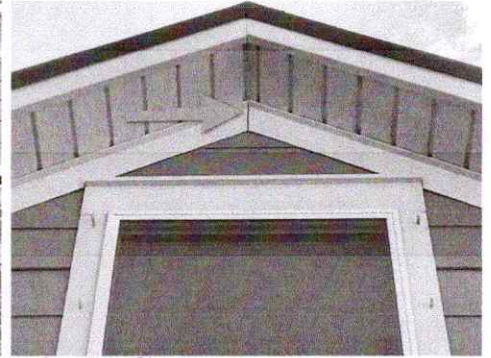
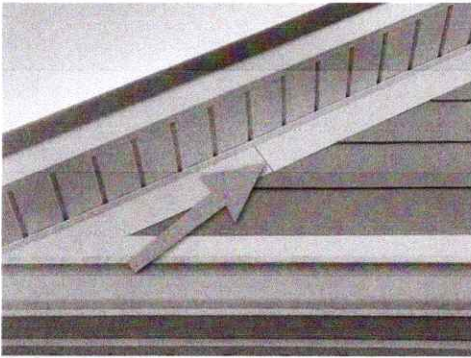
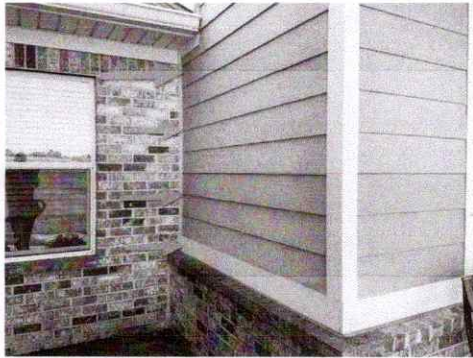
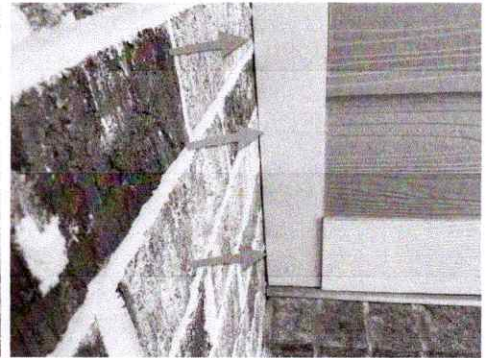
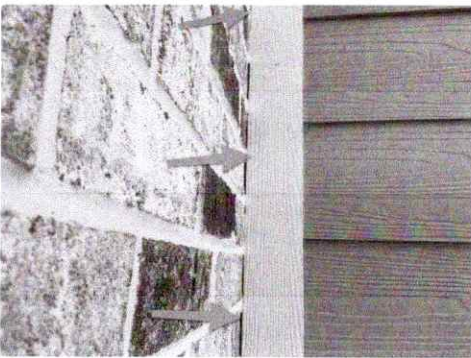
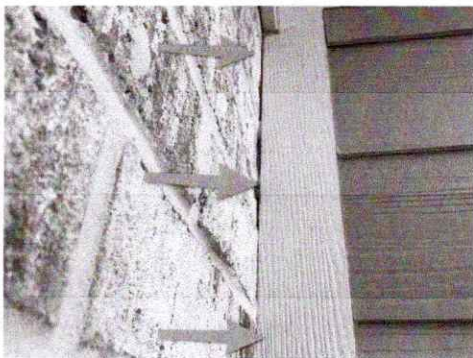
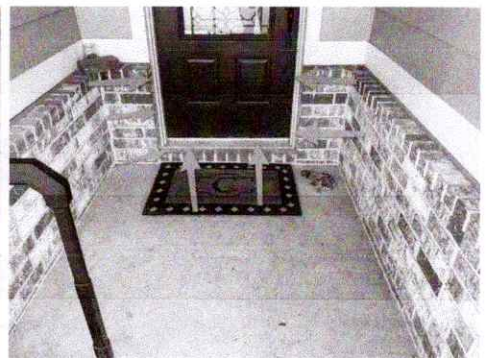
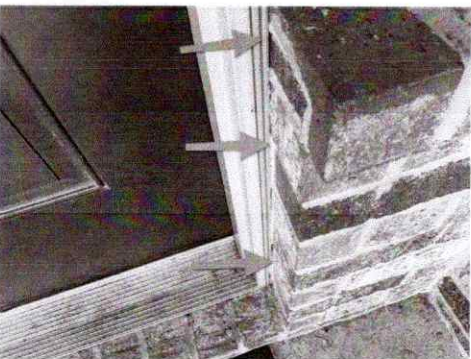
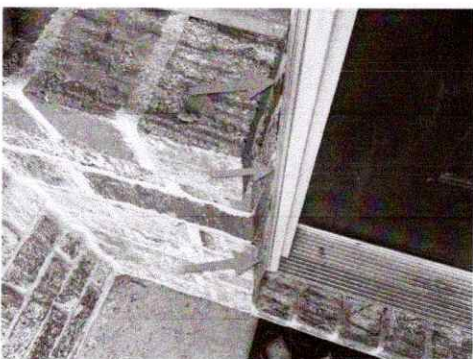
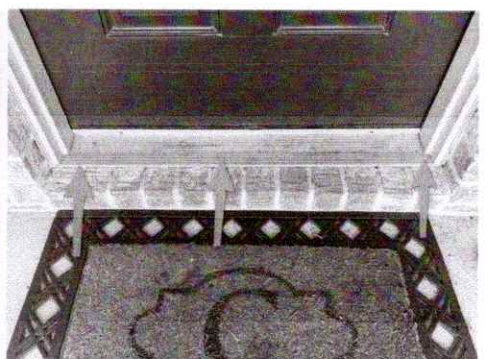
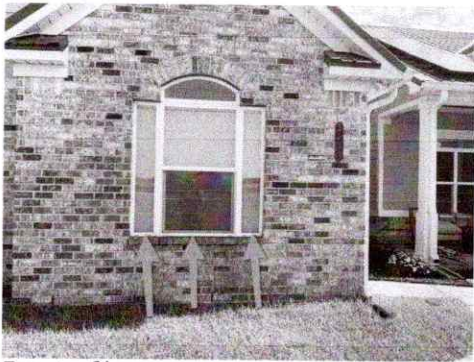
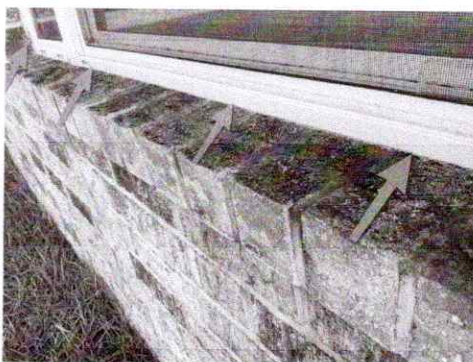
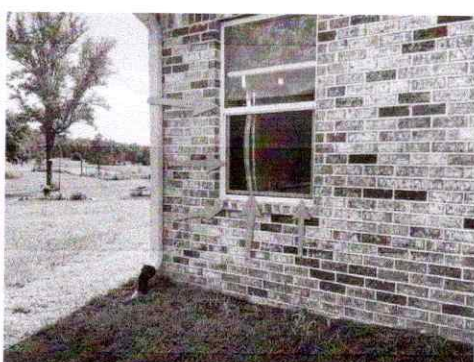
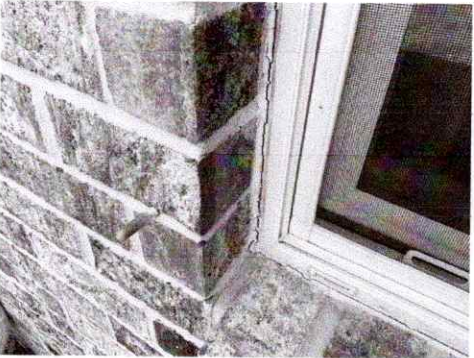
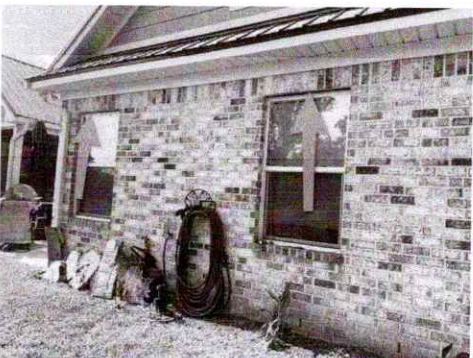
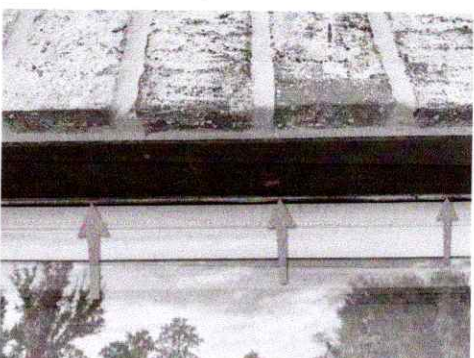
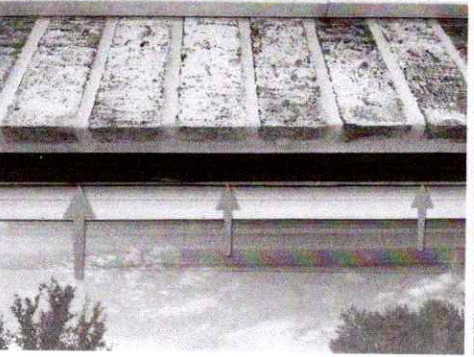
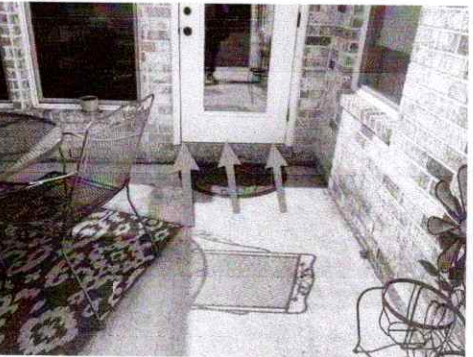
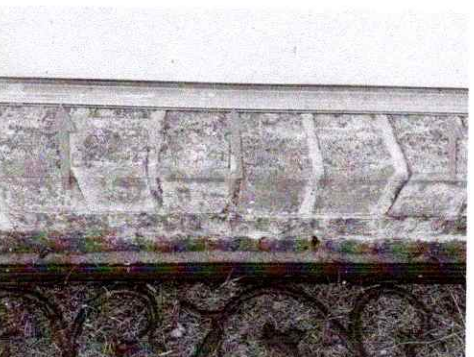
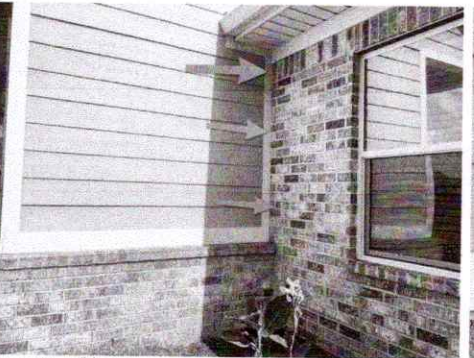
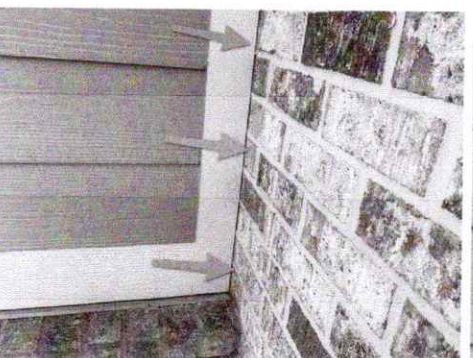
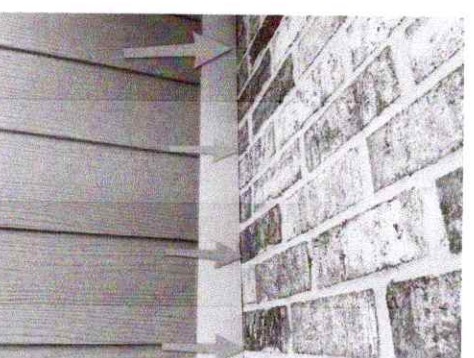
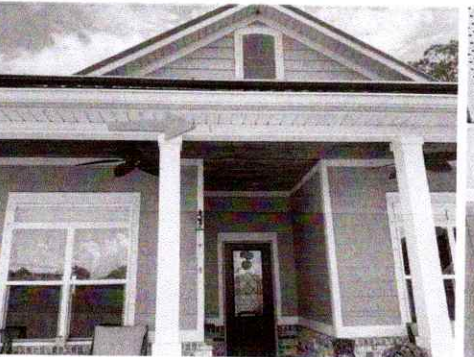
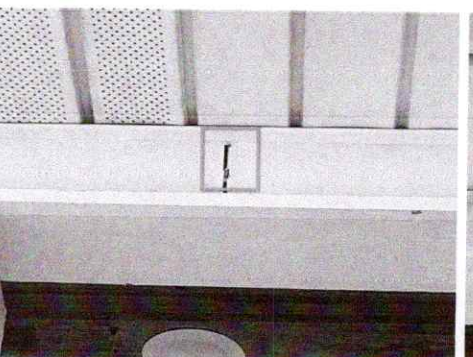
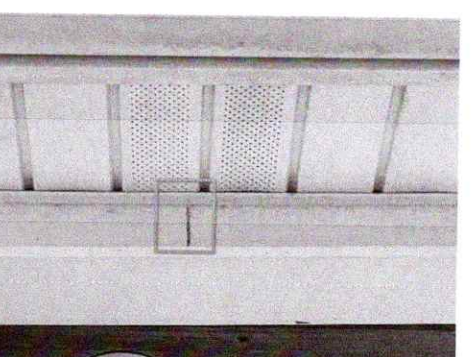
- Exterior siding and penetrations, such as doors/windows in referenced areas has missing or deteriorated caulk. Adding or replacing a fresh bead of exterior rated sealant will prevent pest/water intrusion and increase the thermal efficiency of the home. Recommend repair.

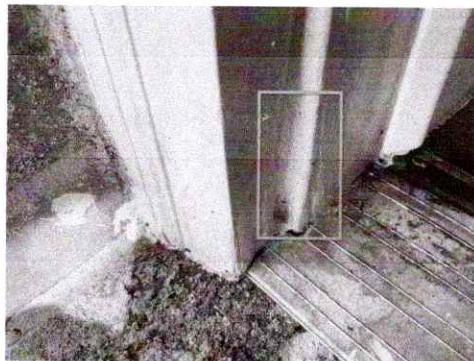
Rear of home

- Door(s) and/or frame has damage or deterioration. This can decrease the energy efficiency of the home and allow water and pest intrusion. Recommend repair.

Soft to the touch

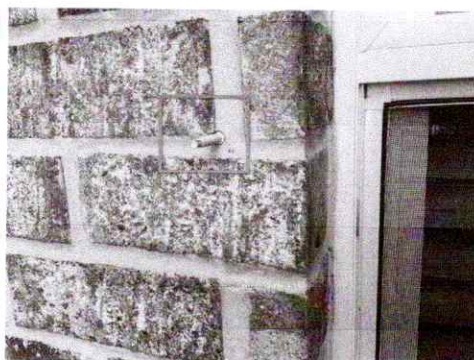
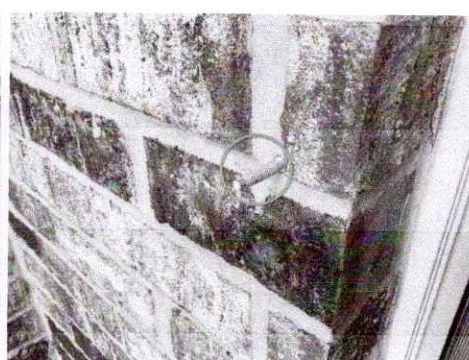
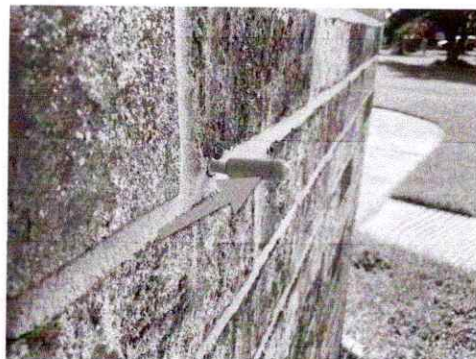
Front of home

- Storm protection hardware, installed around perimeter of exterior openings , are not equipped with their covers in one or more areas, exposing them to the elements, which can promote rust- recommend repair.

Covers being referenced

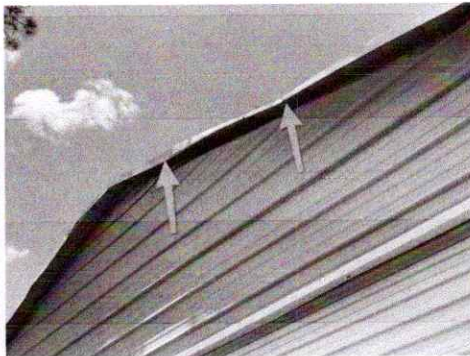
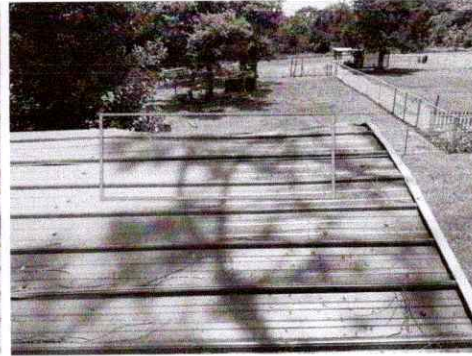
Dents/damage were located on the front and roof of the detached structure- the roof covering was unsecured as a result-recommend repair

Dent

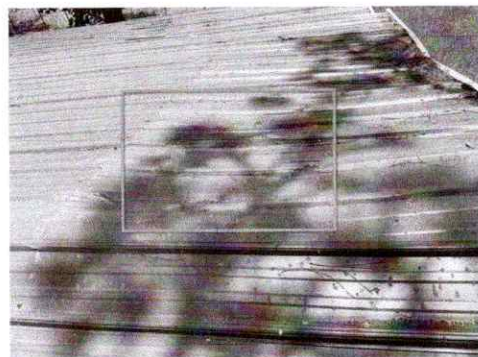
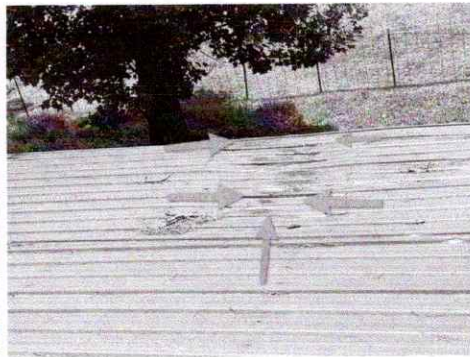
Roof

Dented here also

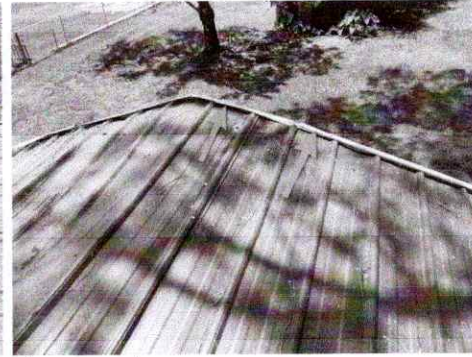
Unsecured

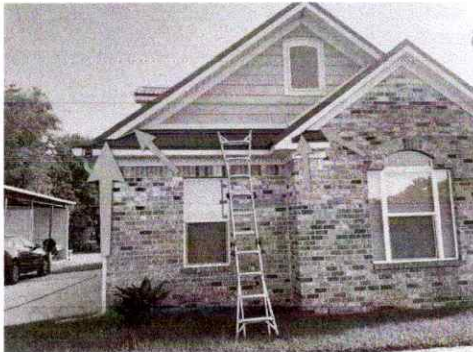
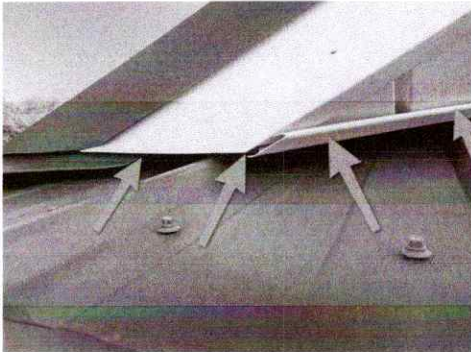
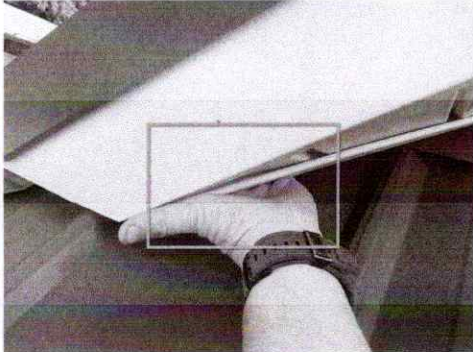
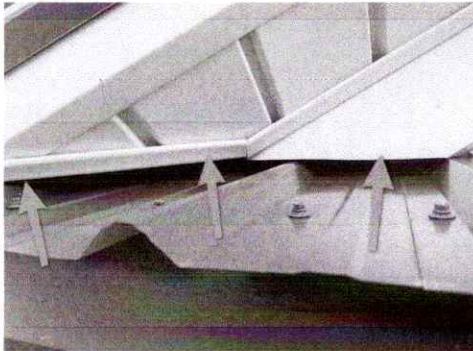
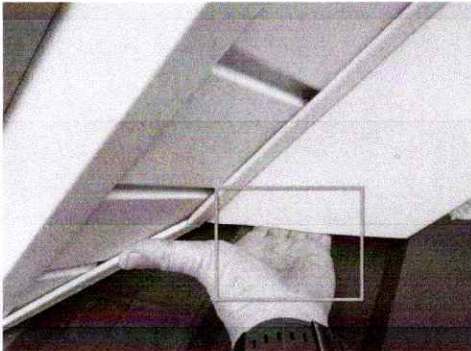
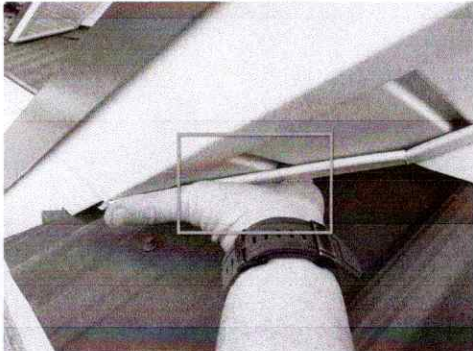
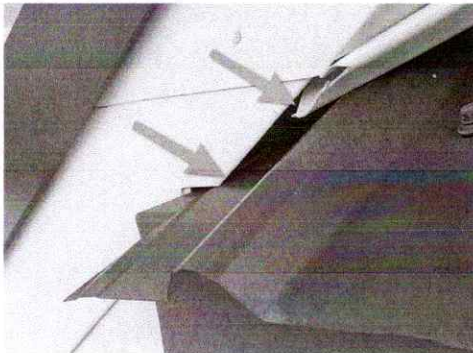
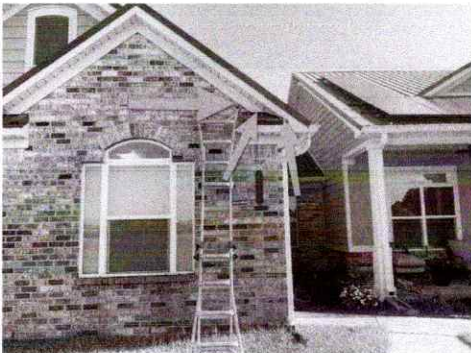
Front of home

- Potential moisture/pest entry point/s into the home on roof structure- recommend repair/sealing.

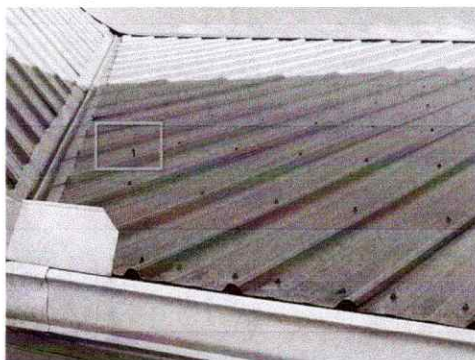
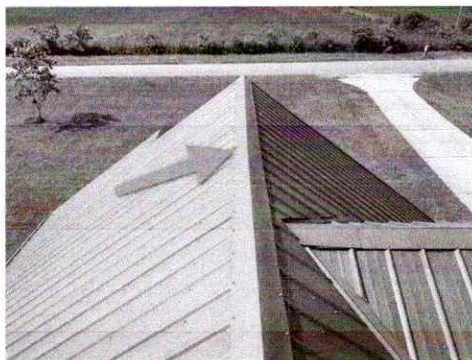
Unsecured- above garage

**METAL ROOF-SCREWS -MISSING/UNSECURED**

- Screws used to secure metal roof panels are missing and/or unsecured in areas, leaving roof improperly and inadequately secured and presenting water entry points-recommend repair by licensed roofer

Unsecured- Front of home

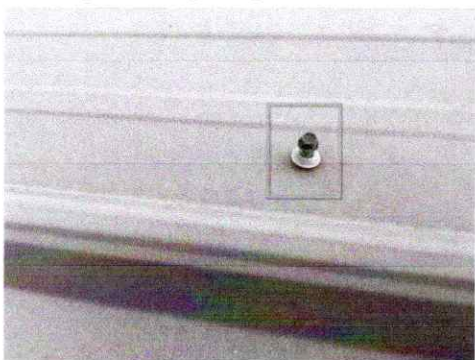
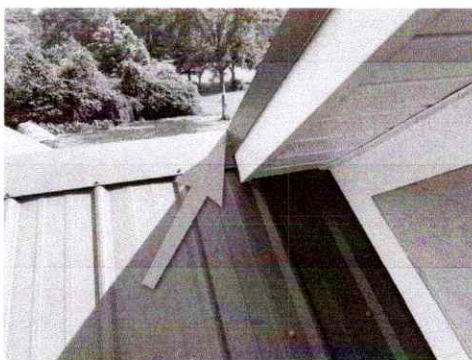
Unsecured

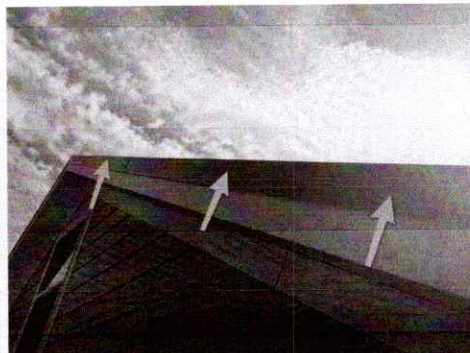
Left side of home

**DRIP EDGE- LACKING SCREWS**

The drip edge flashing around the perimeter of the home was observed to be lacking screws or fasteners at appropriate intervals. Properly securing drip edge flashing is essential to ensure it remains in place during high winds and prevents water intrusion behind the fascia and into the roof decking. Missing or widely spaced fasteners may lead to separation, allowing moisture penetration, wood rot, and potential damage to the roof structure and exterior finishes. Recommend evaluation and correction by a licensed roofing contractor.

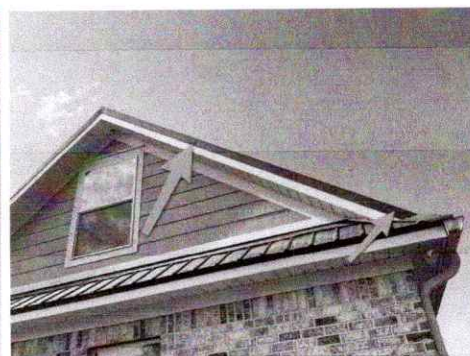
This is approximately the average distance between screws

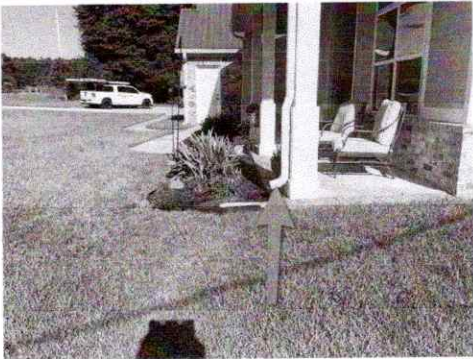
Front of home

- **One or more downspouts drain too close to the foundation. This can result in excessive moisture in the soil at the foundation, which can lead to foundation/structural movement. Given this areas high annual rainfall, water management is an important factor to consider and implement- Recommend adjusting downspout /adding extensions to drain at least 6 feet from the foundation.**

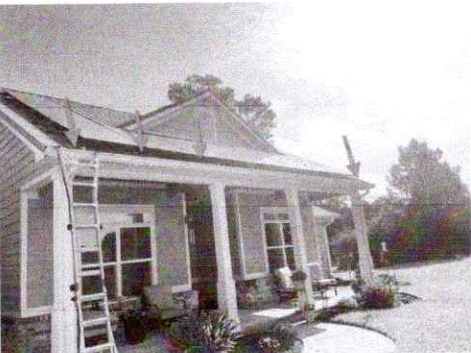
Front of home

- **Dirt/Debris located in gutter system which can/has cause/d water stand- recommend removal of debris to allow to travel to its intended targets.**This also adds additional weight to this system which can cause gutter system to pull away from the home-Given our high annual rainfall, maintaining a clean gutter system is highly recommended.

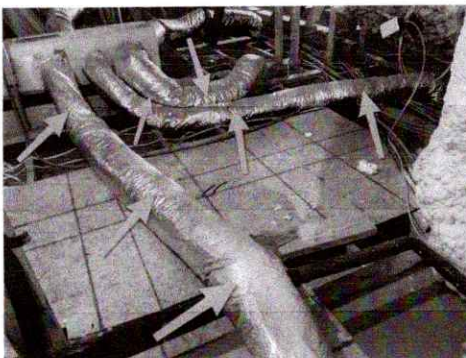
- One or more areas located in the attic where ductwork was installed/located along the rafters/beams- recommend adding bracing here so that ductwork does not make contact with the rafters/beams.

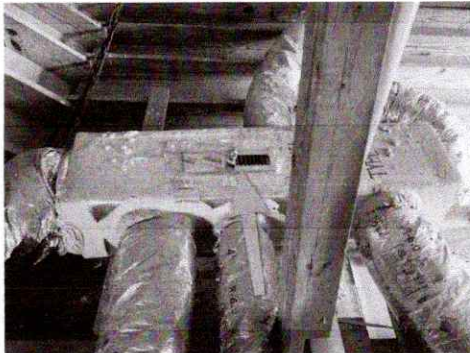
Open vent registers were observed on the HVAC supply plenum located in the attic. This configuration is not standard, as it allows conditioned air to be discharged into an unconditioned attic space, resulting in energy inefficiency and potential system imbalance. The purpose of this vent is unclear, and it does not appear to serve a finished or climate-controlled area. Recommend further evaluation and correction by a licensed HVAC contractor to ensure proper system performance and energy conservation.

Open vent here

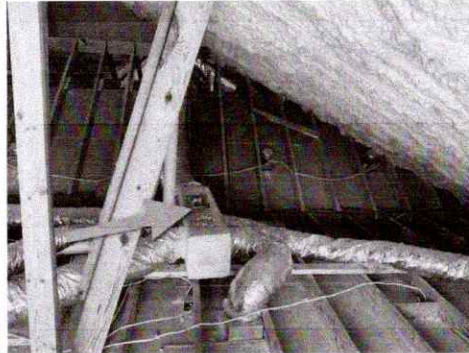
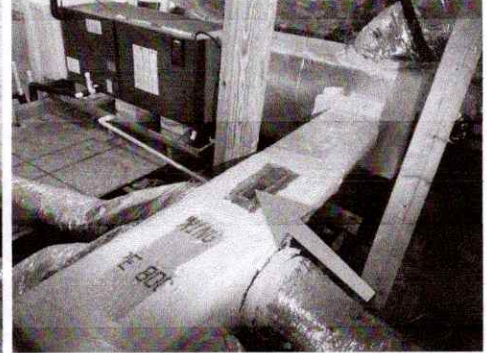
Additional vent here
